FINAL REPORT

# YELLOW FLAG IRIS MITIGATION – LAKE MINNESUING

**JUNE 3, 2015 – DECEMBER 31, 2020**

**SPONSOR – LAKE MINNESUING SANITARY DISTRICT**

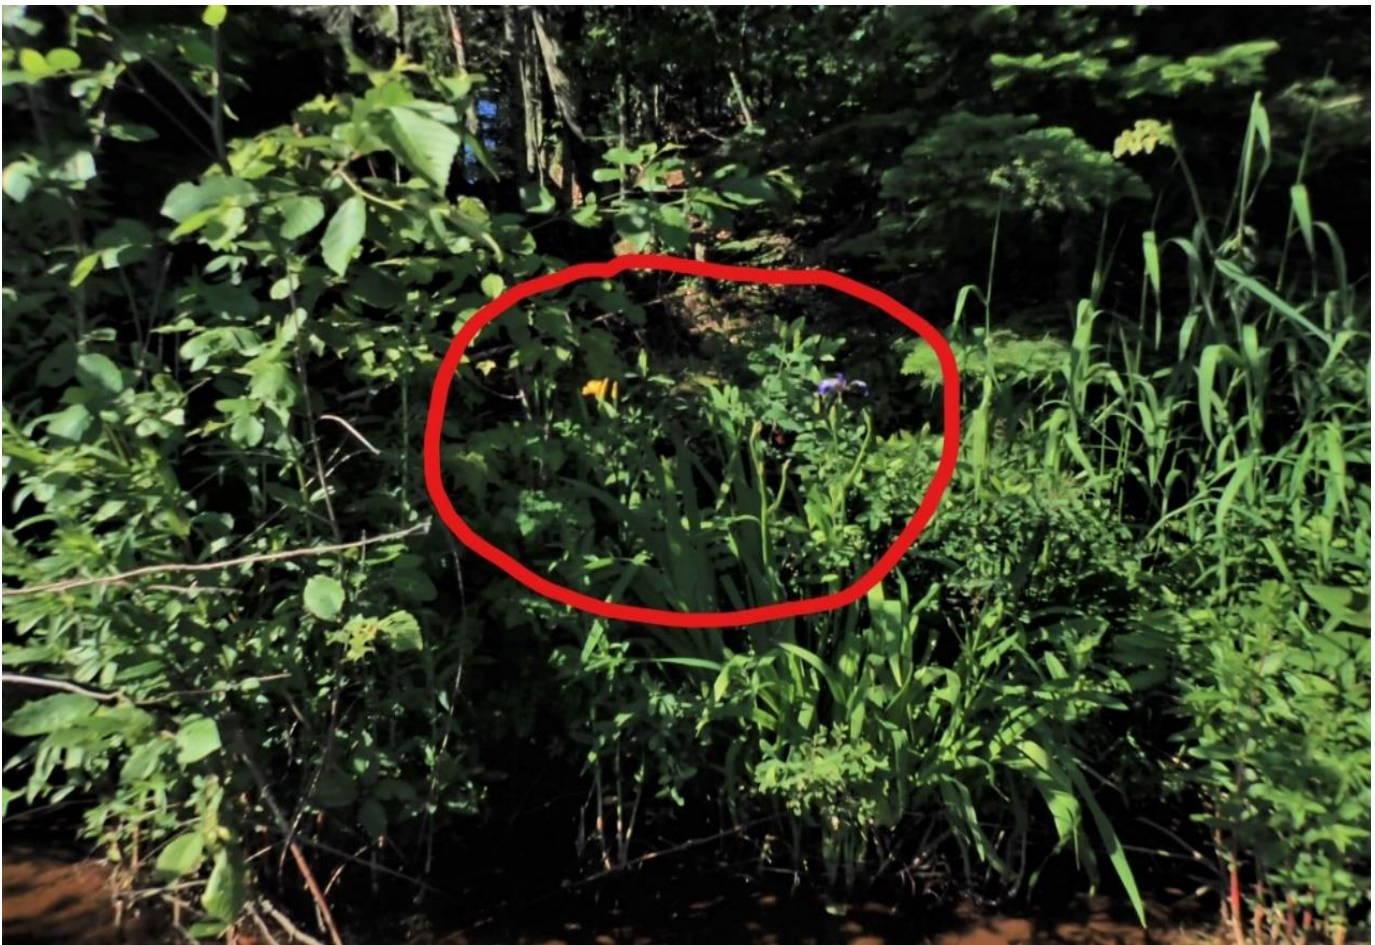
6/22/16 (P6220437) Yellow and Native Blue growing side by side on Lake Minnesuing's island

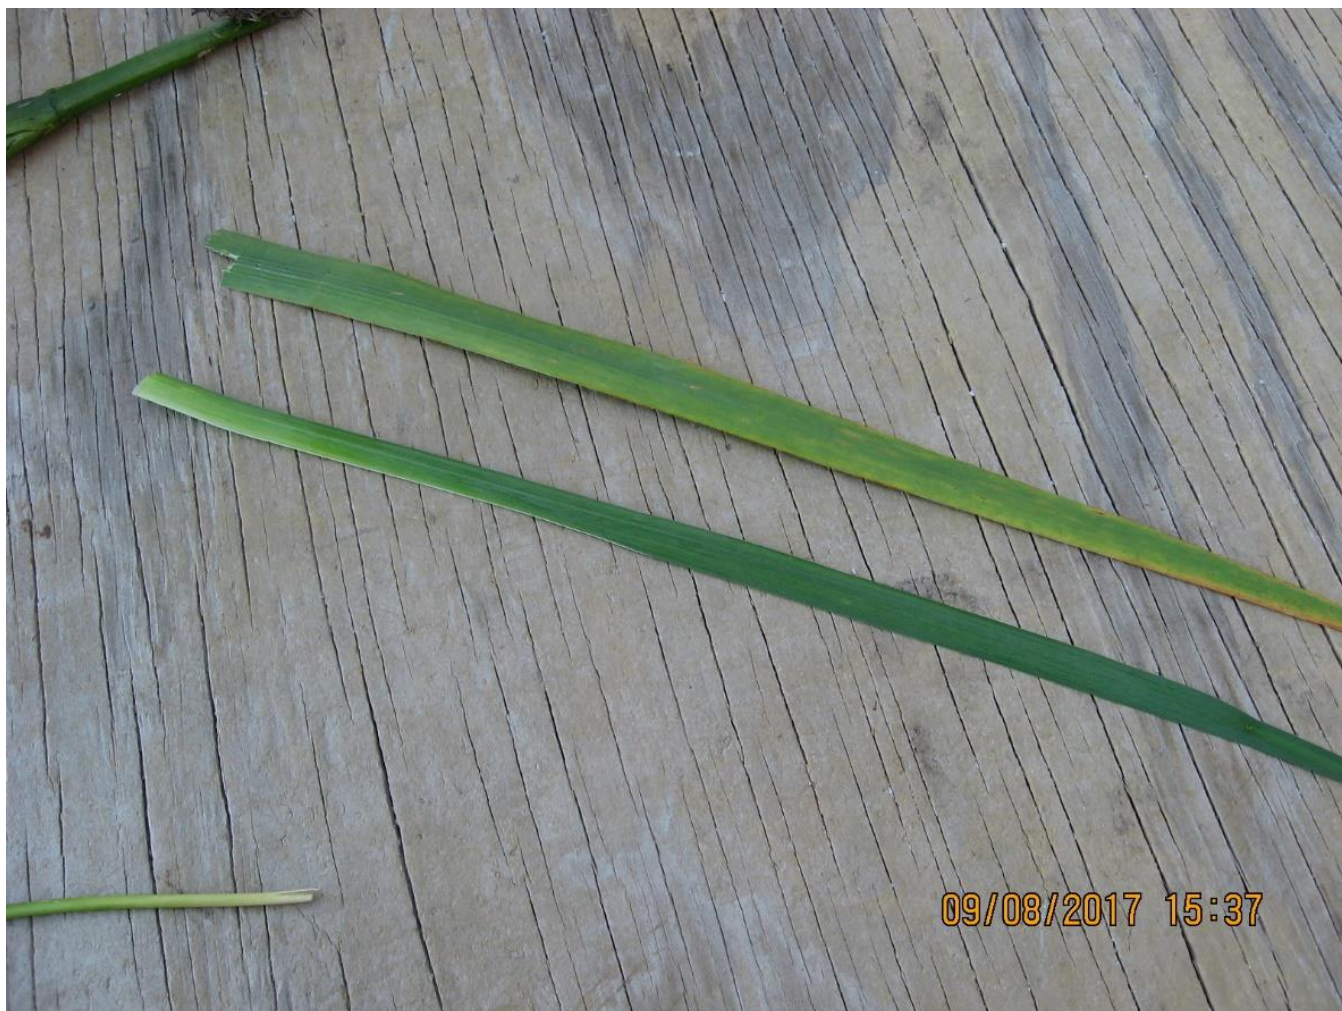
Leaf comparison Yellow above, Blue below

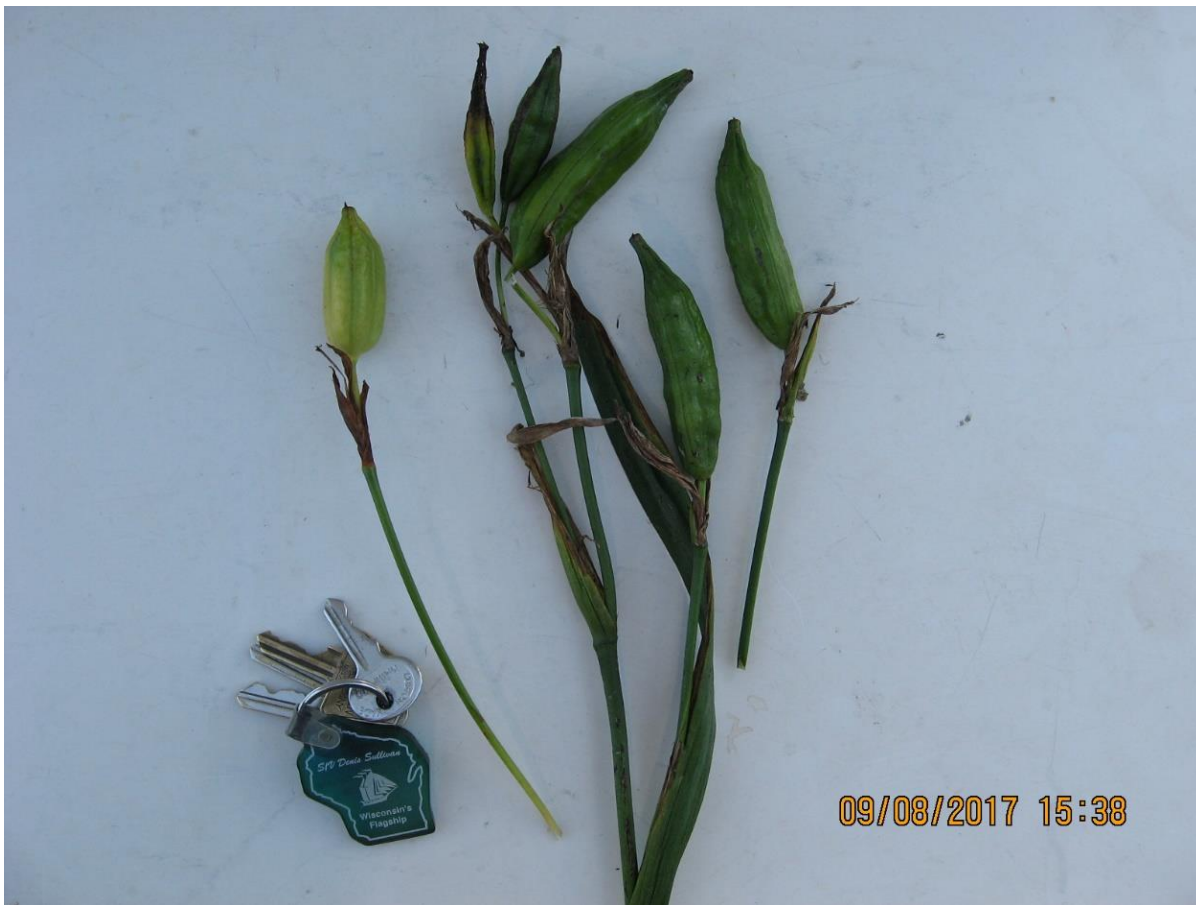
Seed pods Yellow on right, Blue on left

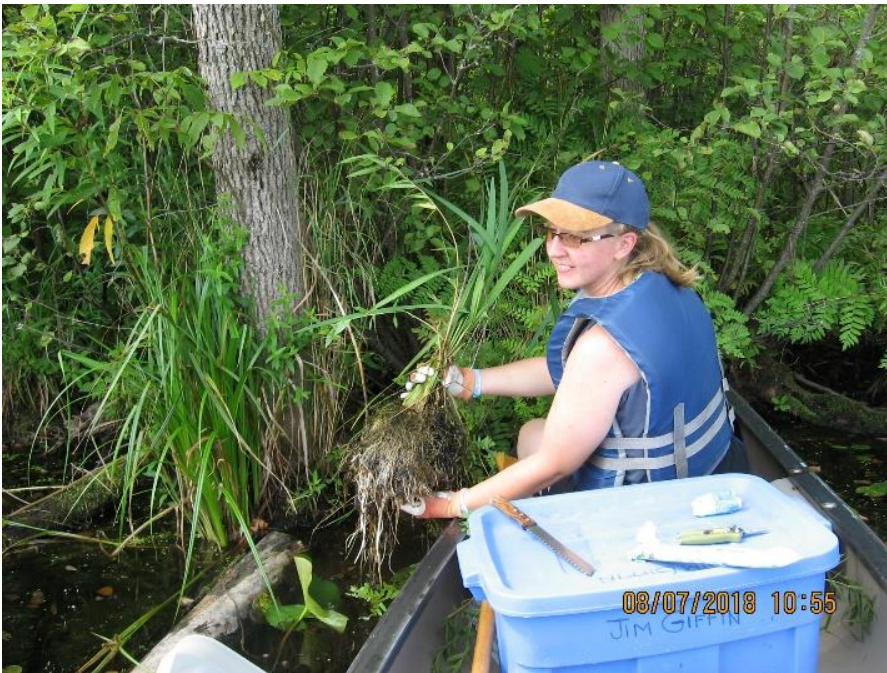
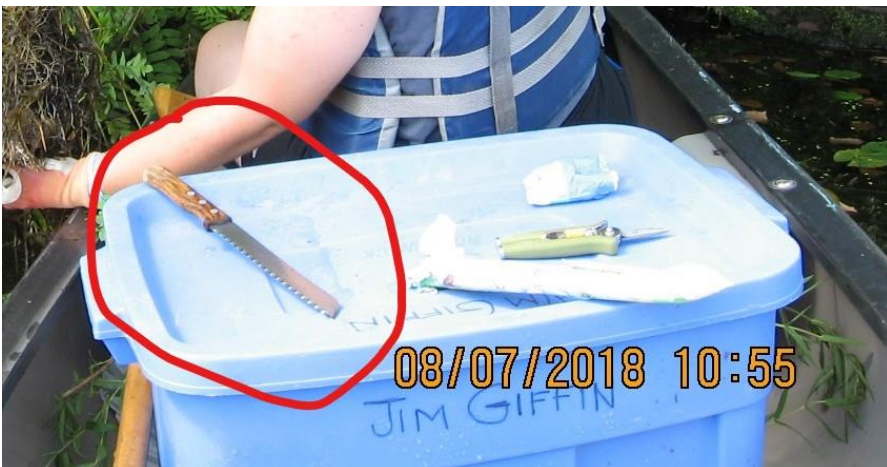
Note the use of the serrated butcher knife. On small stands of YFI this technique can be very effective, allowing most if not all of the rhizome material to be removed. Pictured – Dara Fillmore, WDNR, participating in LMSD’S YFI Work Days. Thank you Dara!

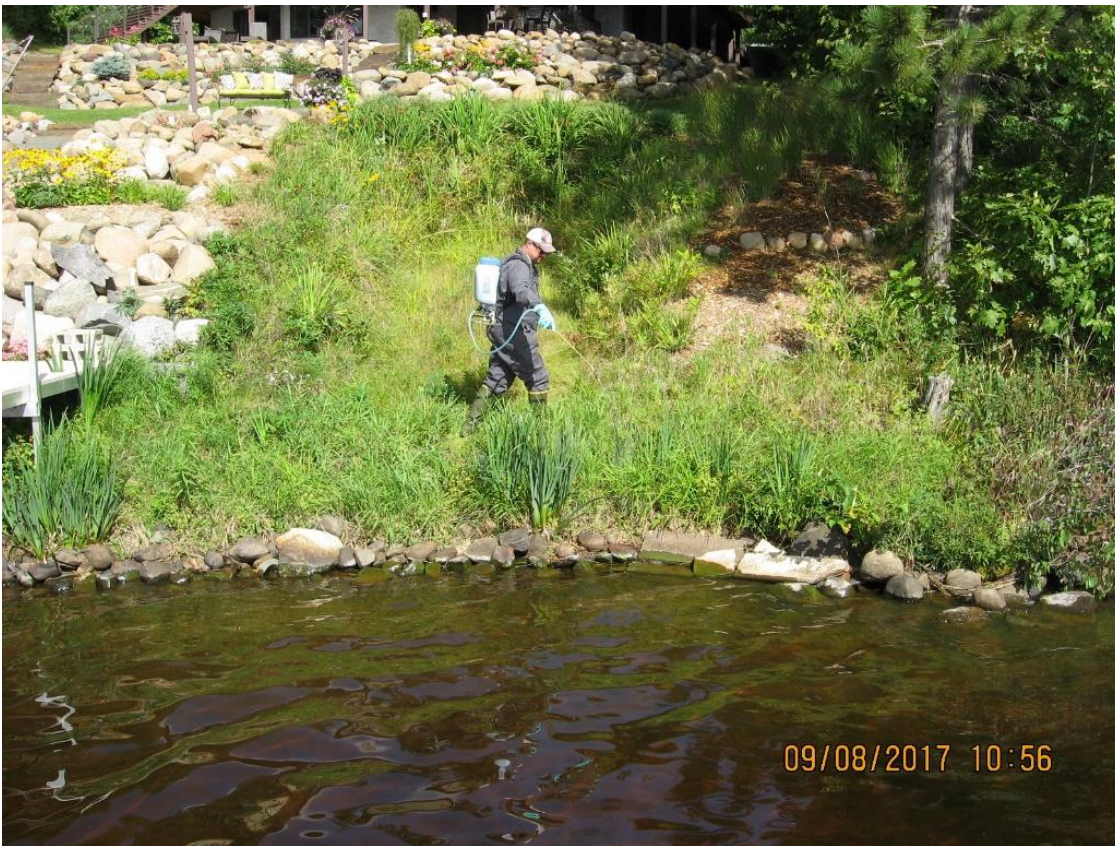
Targeted application with back pack sprayer

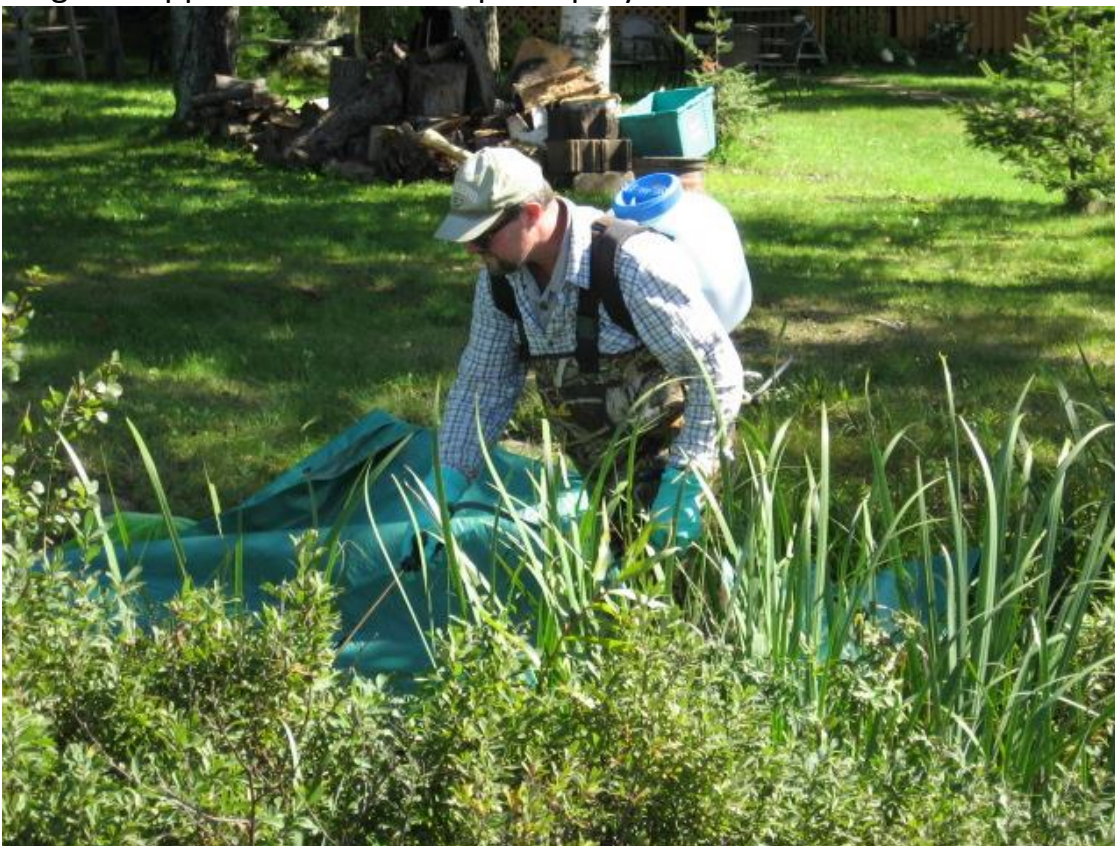
Covering native plants prior to spraying YFI

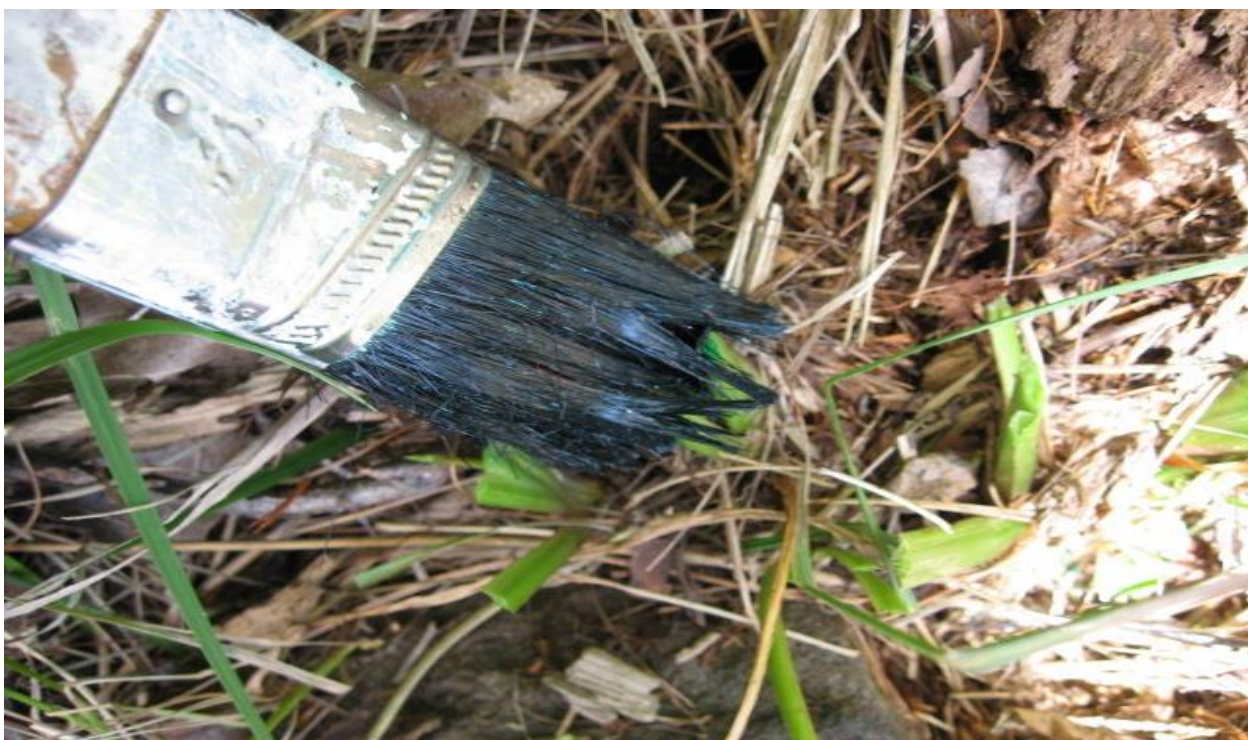
Brushing mixed herbicide on cut stump of YFI

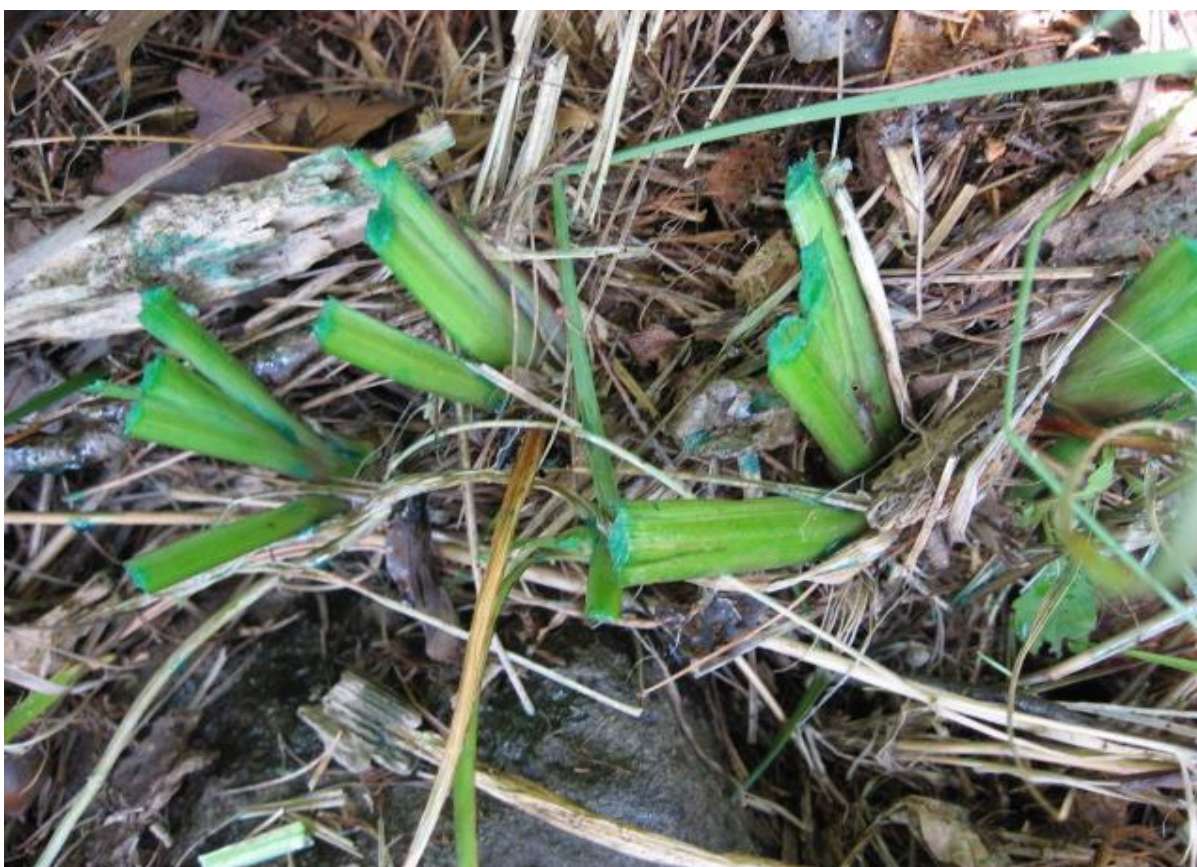
Notice the “blue tint” of the cut stump after treatment. It may not seem like it but it is often difficult to find the YFI stumps you have just cut and to know which of them you have already

treated when they are mixed in with other vegetation. A blue dye, mixed with the herbicide, is very helpful to know where you have already treated.

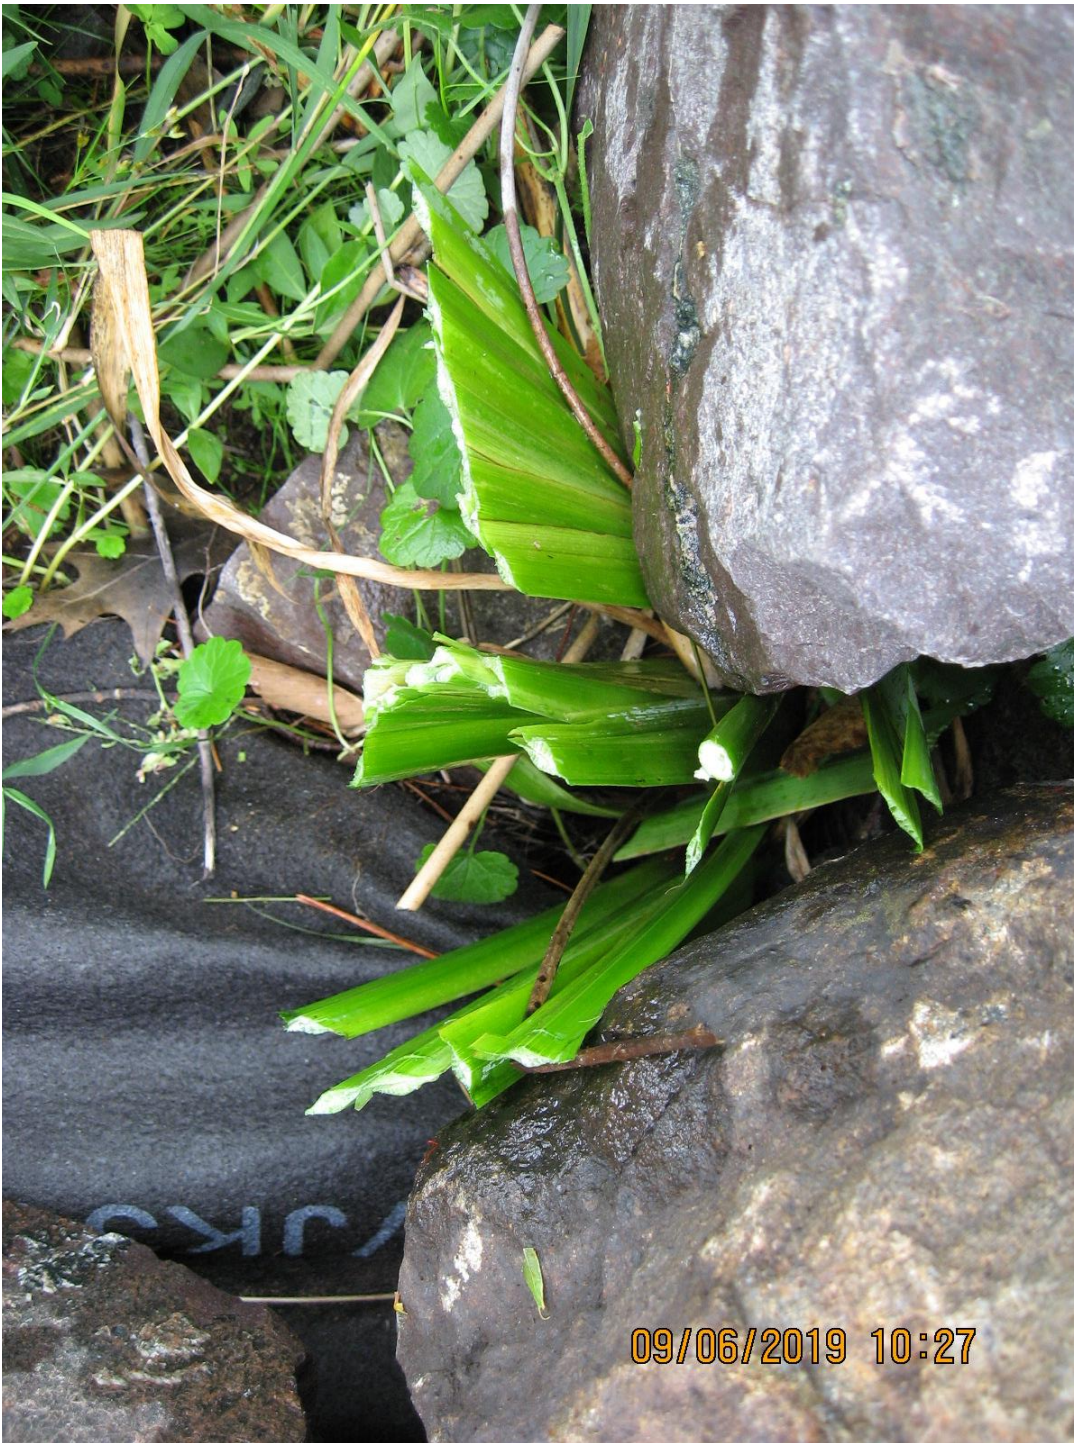
Cut YFI prior to treatment

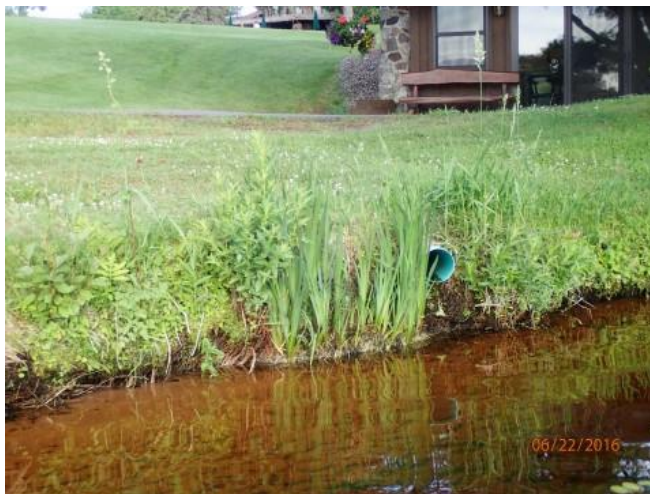
6/22/2016 - Not only was this a YFI treatment candidate but we have a storm water drainage pipe problem in this area too! LMSD treated this site in 2016 using the fleece glove treatment.

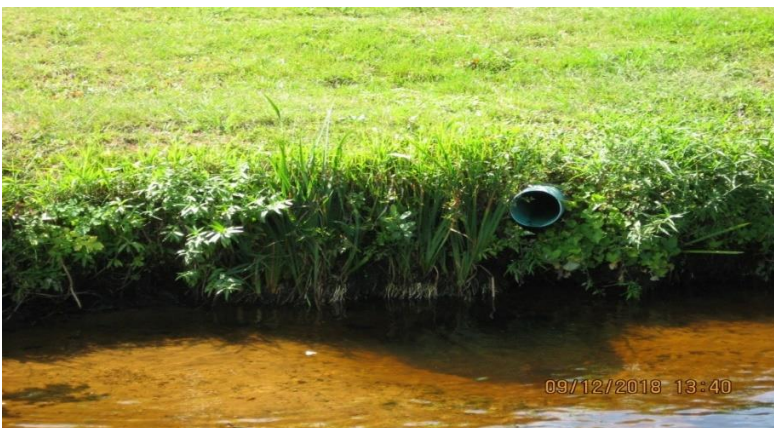
During our assessment 6/12/17 this plant appeared to be gone (it was earlier in the growing season however). On 9/12/2018 regrowth of reduced size was observed. This site was retreated by spraying in 2018.

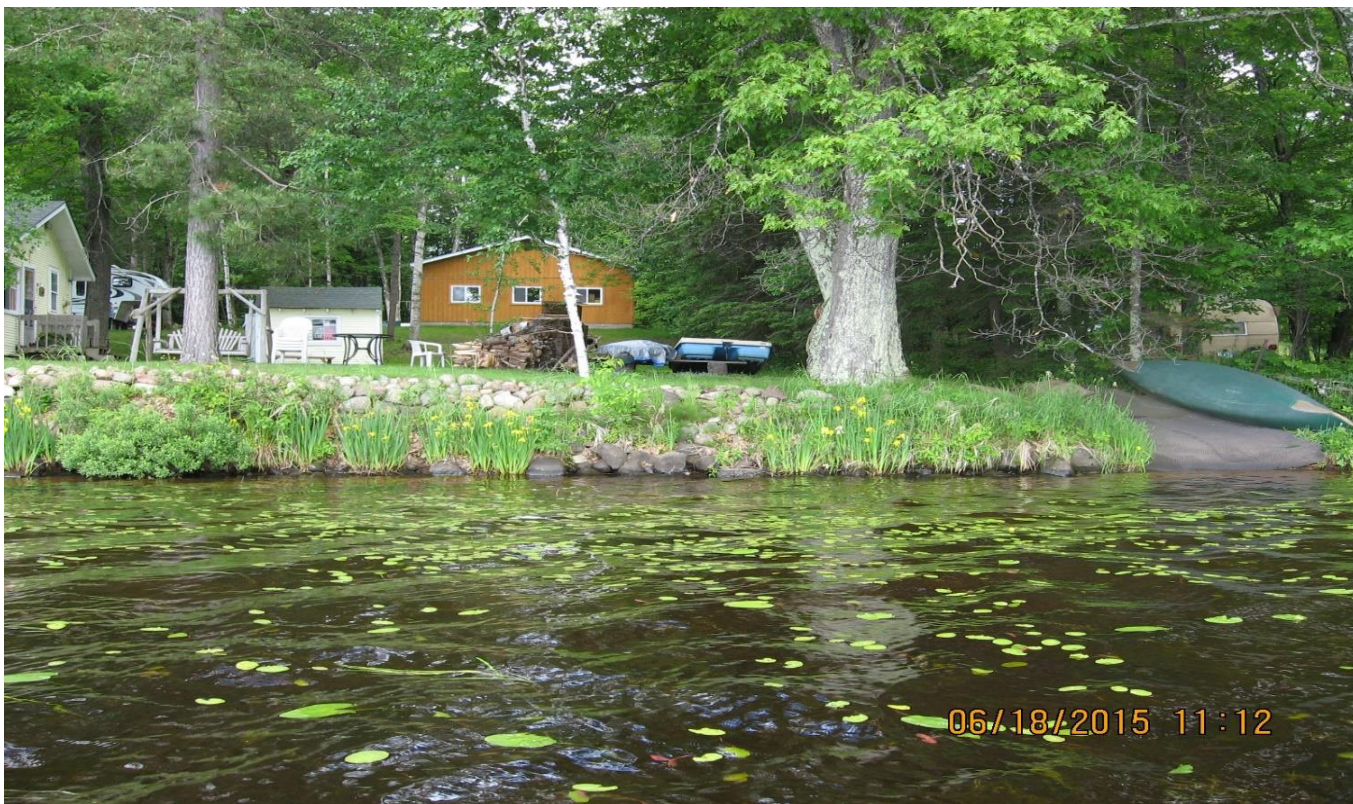
6/18/2015 Prior to treatment Property 9800 North – multiple stands of flowering YFI are apparent

Property 9800 was treated in 2015 and 2016 using a “butcher knife” digging or carving technique. The property owner developed the process and completed the work. Where a shovel was impractical in the fully rocked shore the knife was very controllable and allowed targeted digging with nearly complete removal of rhizomes resulting in very limited collateral damage to the shore.

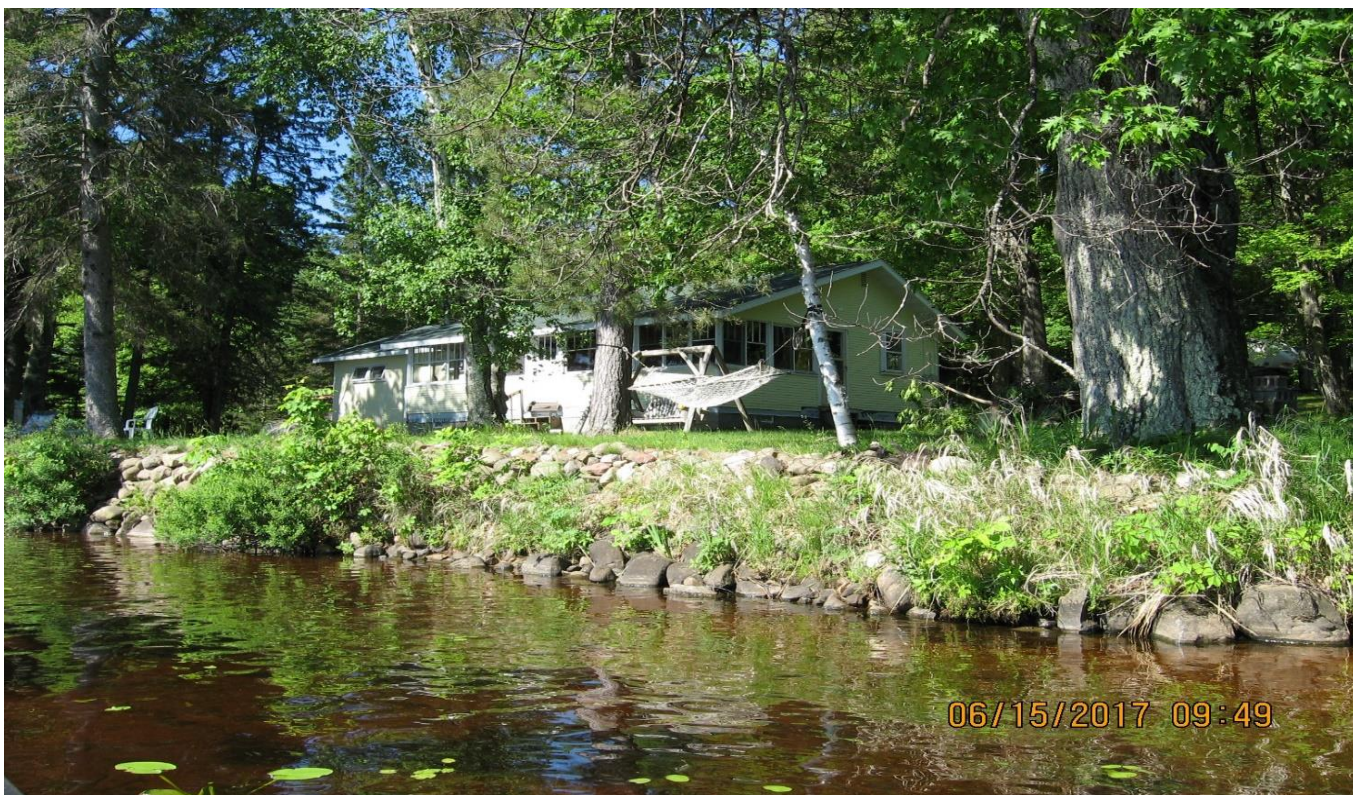
6/15/2017 Property 9800 north "after" – there is one YFI plant remaining shown in close up in the "after" photo that follows

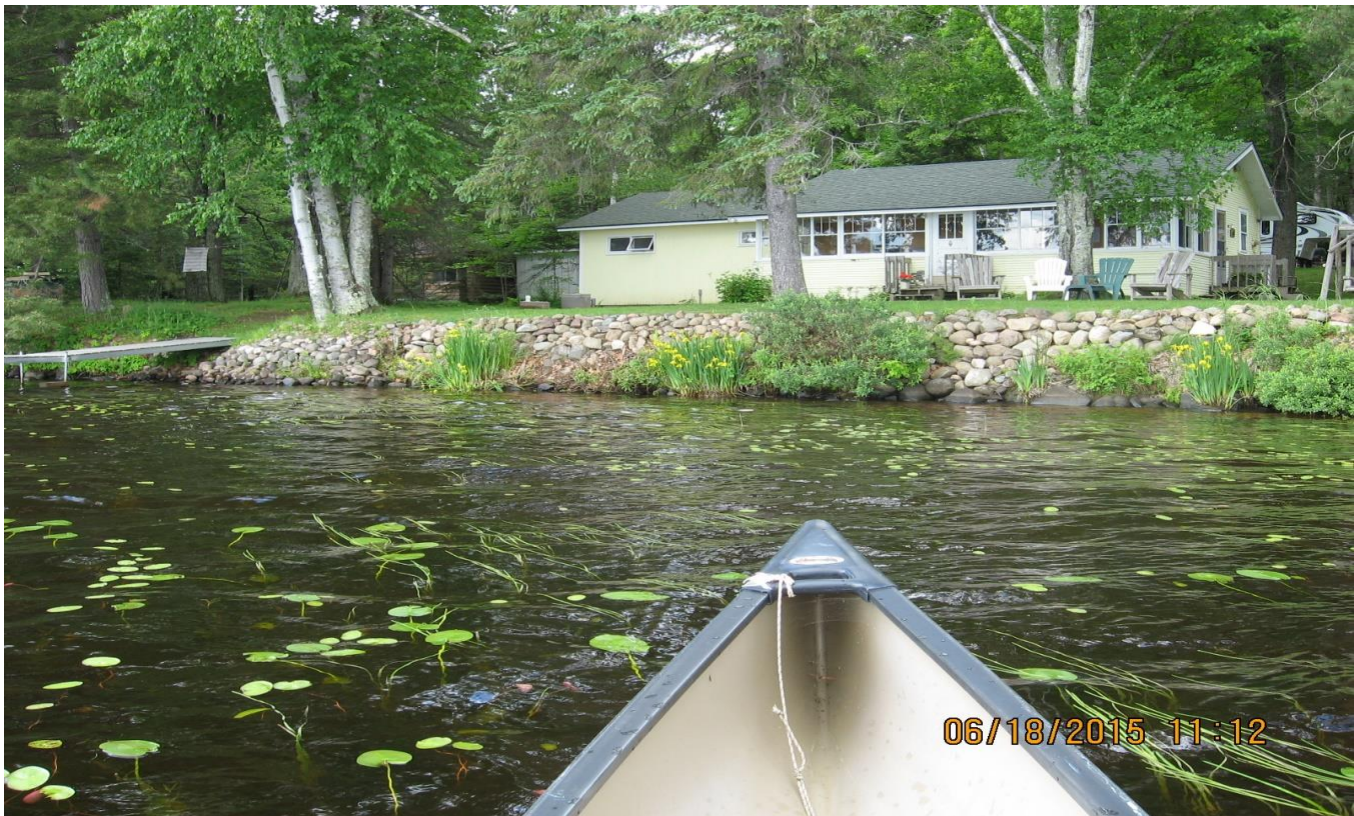
6/18/2015 Property 9800 south "before"

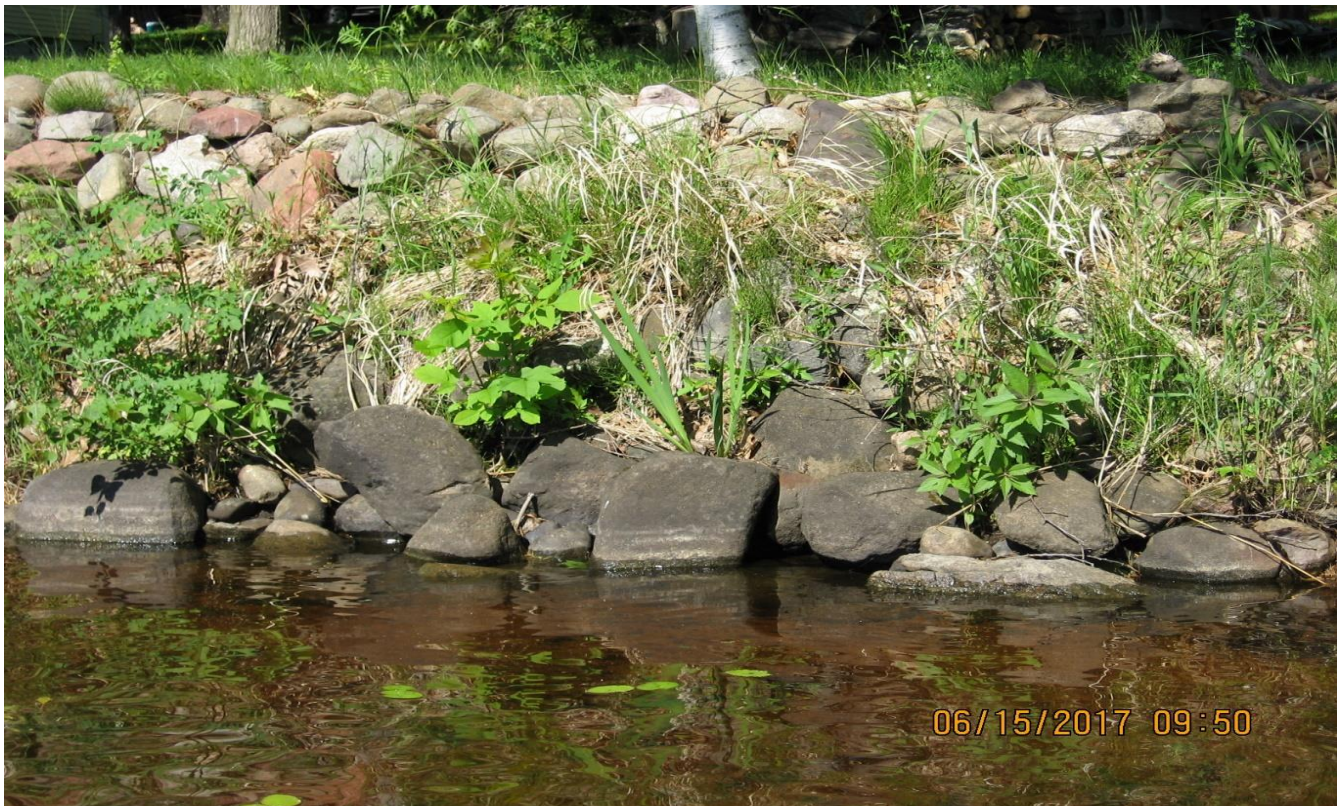
6/15/2017 Property 9800 "after" – this was the only plant noted in the area covered by both the Property 9800 "before" photos above. The area remained clear of YFI in 2020.

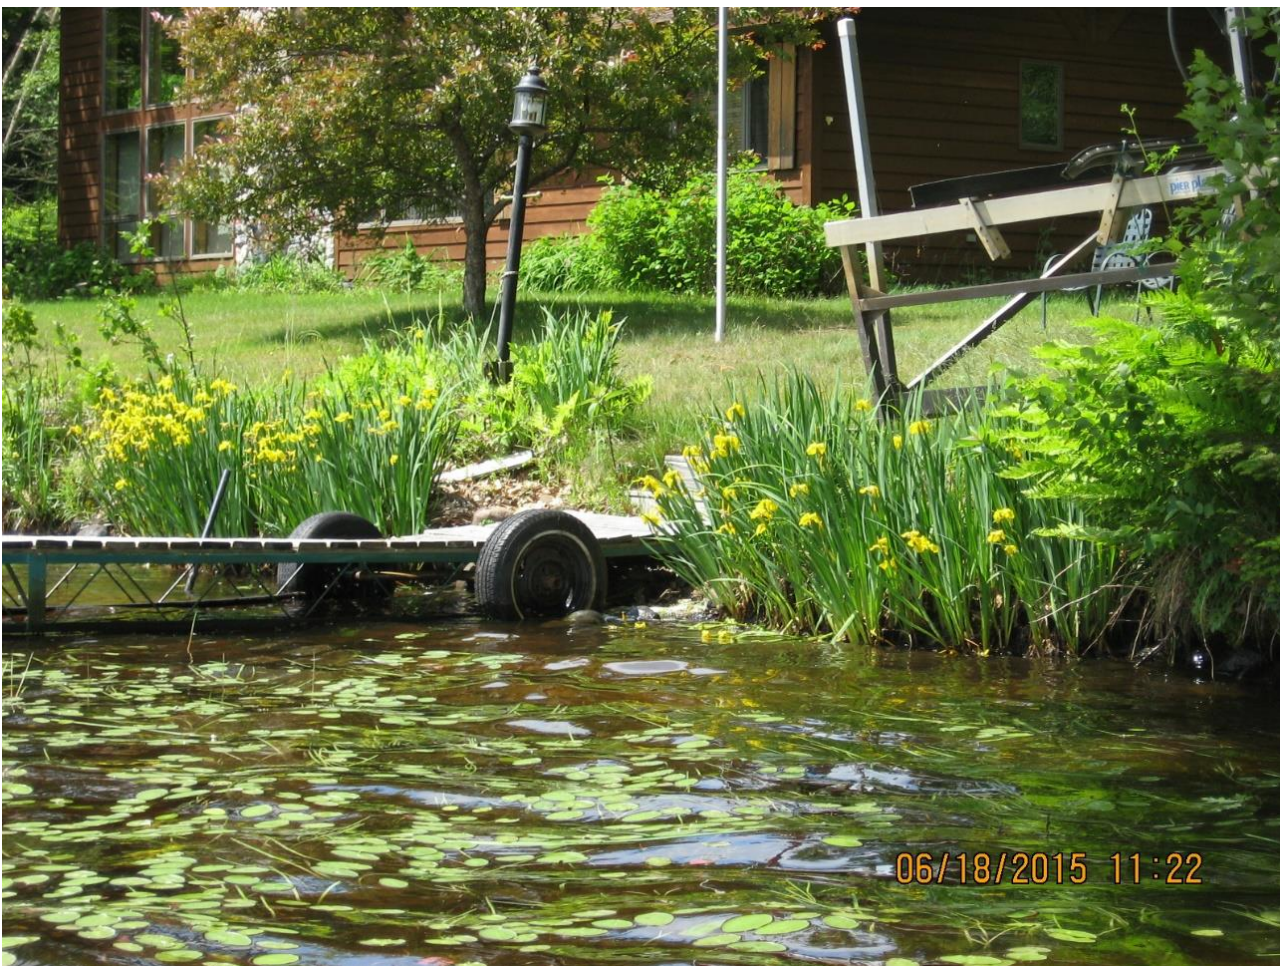
6/18/2015 Property 0200 dock area “before” – large stands of flowering YFI on either side of dock

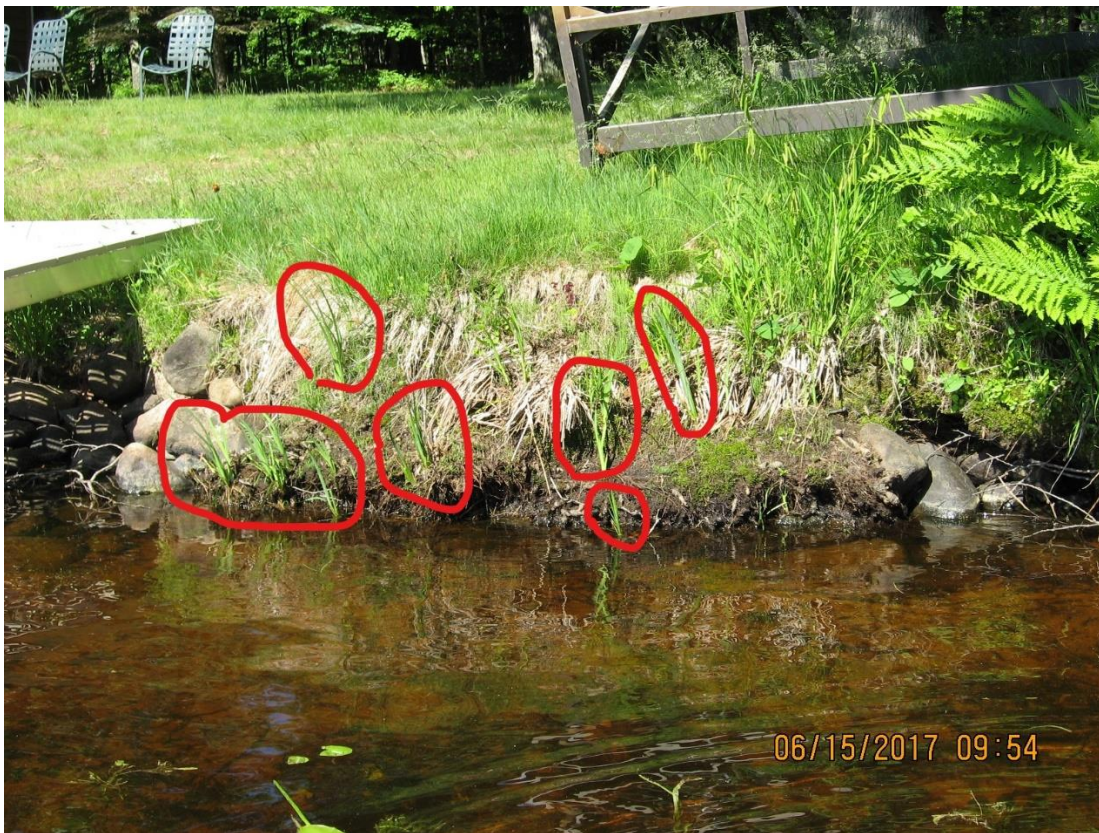
6/15/2017 Property 0200 dock north side “after” 9/8/2016 spraying. Some smaller YFI plants remain.

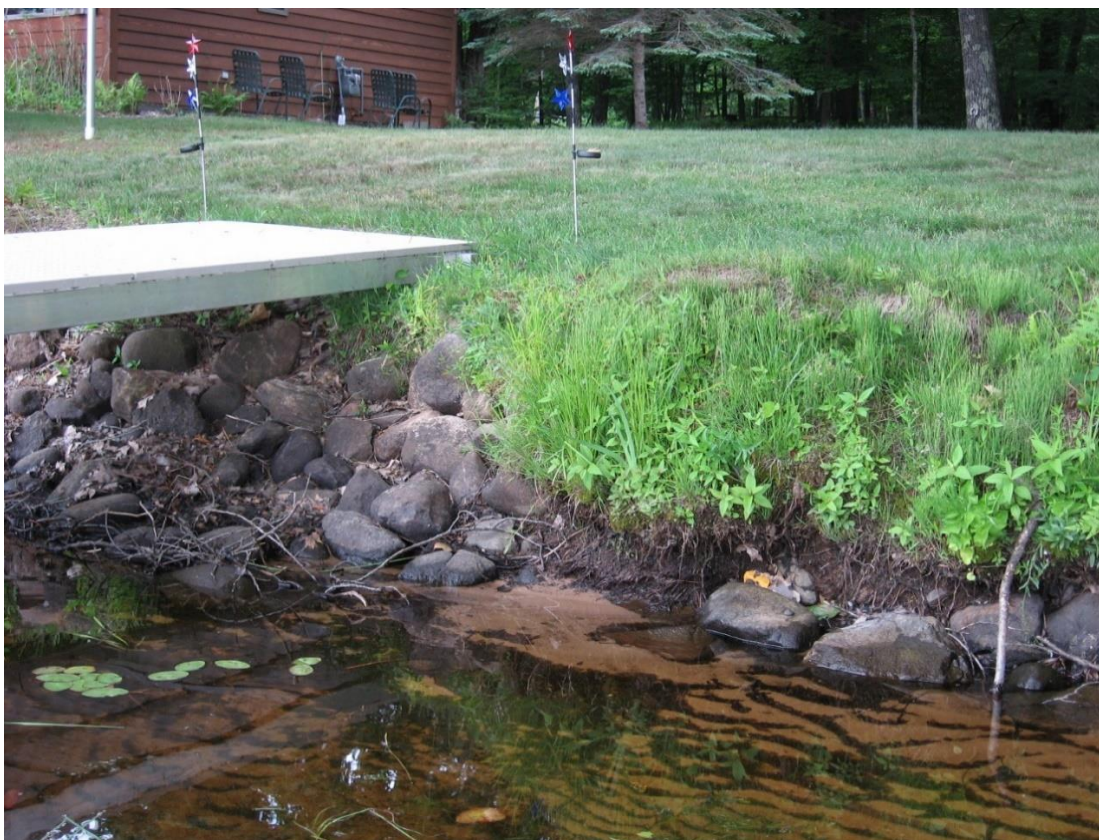
7/1/2020 Property 0200 dock north side “after” 2106 spraying and spray retreat in 2017– one small plant remains which was cut stump treated 9/1/2020

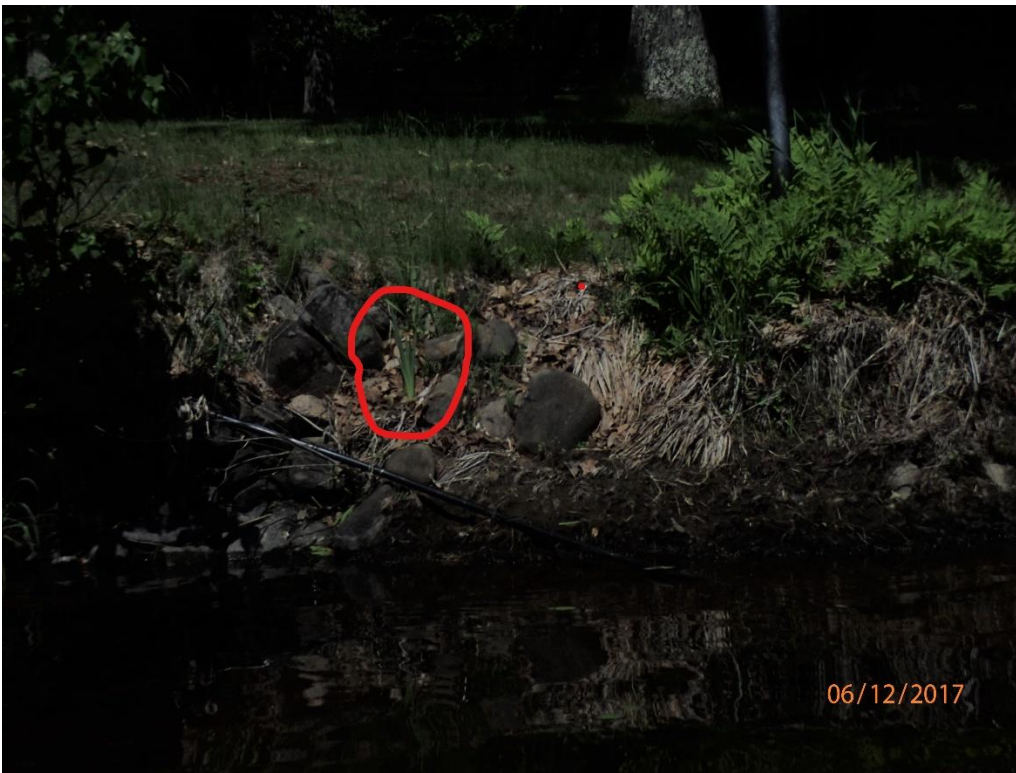
6/12/2017 Property 0200 dock south side "after" spraying 9/8/2016 (black vertical tube is the lamp post in the "before" photos). One relatively small YFI plant is seen in about the center of the photo. This photo does depict the collateral damage that occurs by spraying. The root system of the plants lost do remain in the ground, minimizing erosion that occurs when digging YFI is used as the alternate treatment technique.

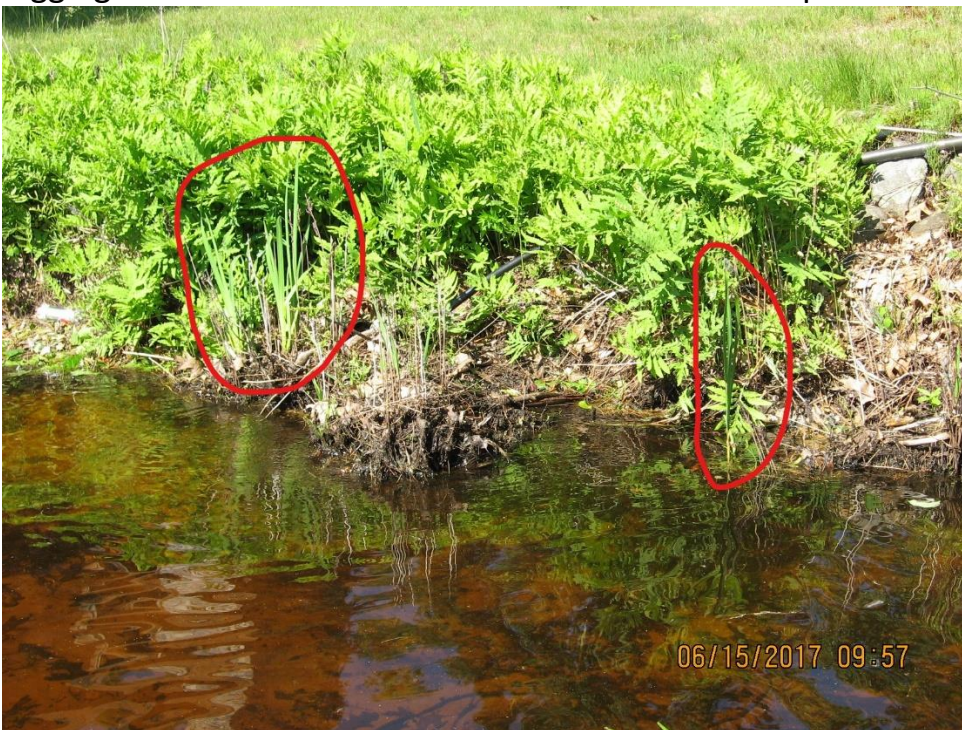
6/15/2017 Property 0200 dock south close up "after" spraying 9/8/2016. Large stand has been reduced to fewer, smaller plants.

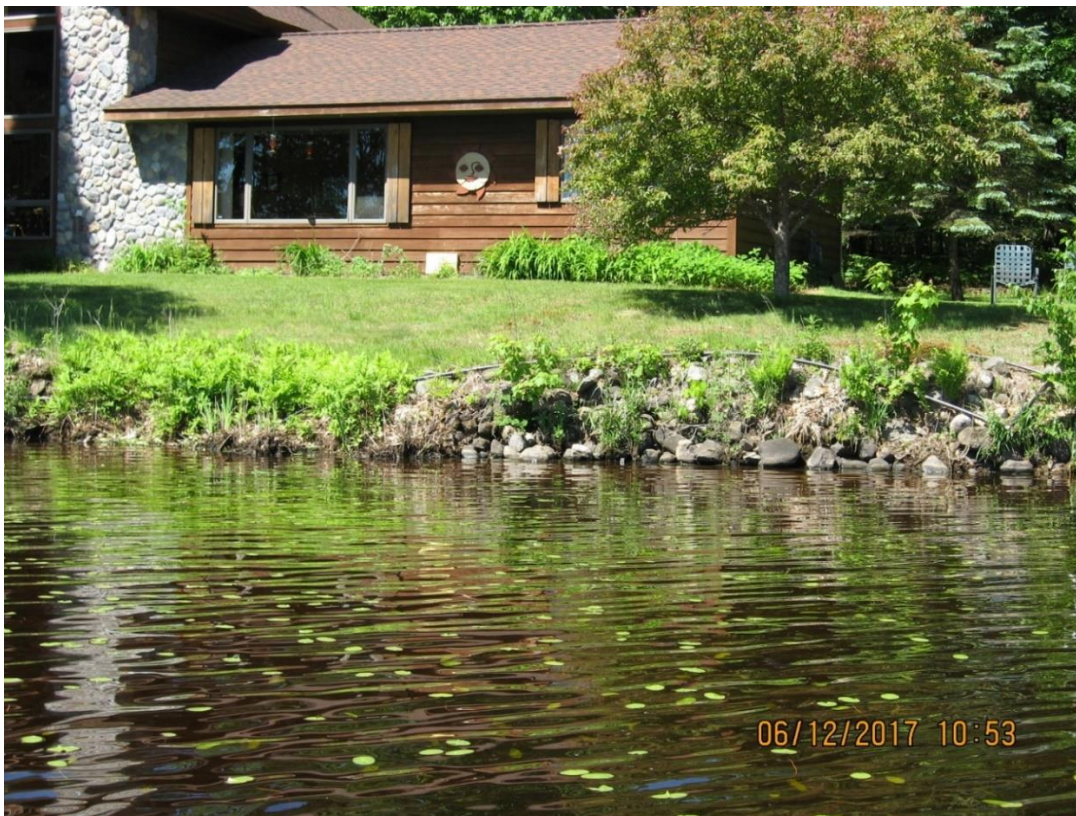
6/12/2017 Property 0200 south “after” – much improved with some small plants remaining later treated by cut stump

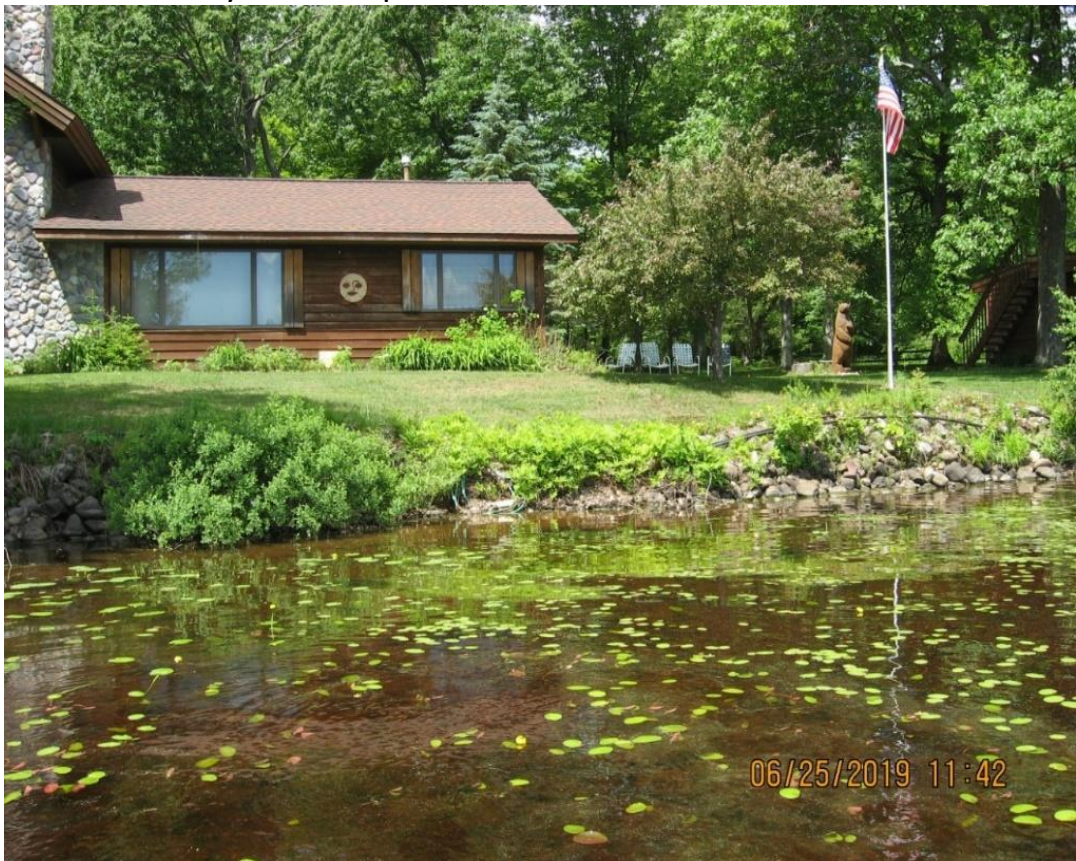
6/25/2019 Property 0200 “after” spraying in 2016 and respray in 2017– YFI has been largely eliminated and remained so in 2020.
