FINAL REPORT

# YELLOW FLAG IRIS MITIGATION – LAKE MINNESUING

**JUNE 3, 2015 – DECEMBER 31, 2020**

**SPONSOR – LAKE MINNESUING SANITARY DISTRICT**

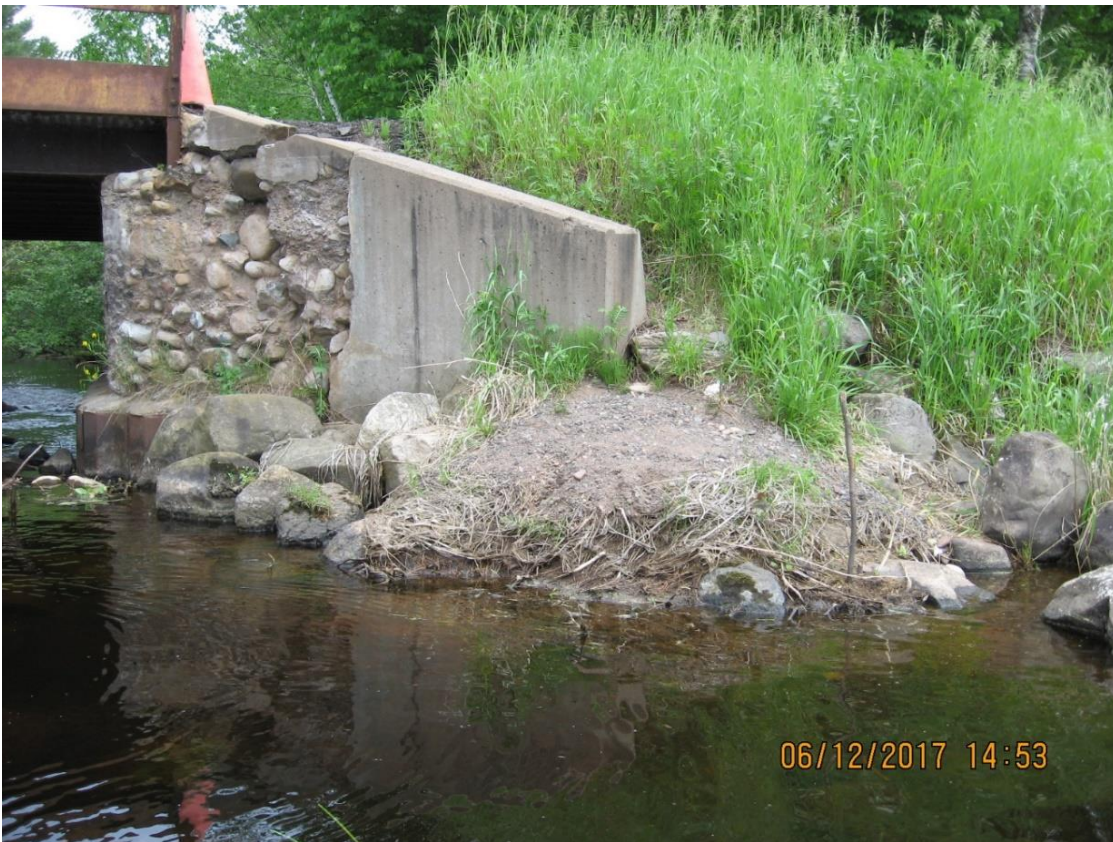
6/12/2017 Minnesuing Creek S side bridge abutment 9 months “after” spraying

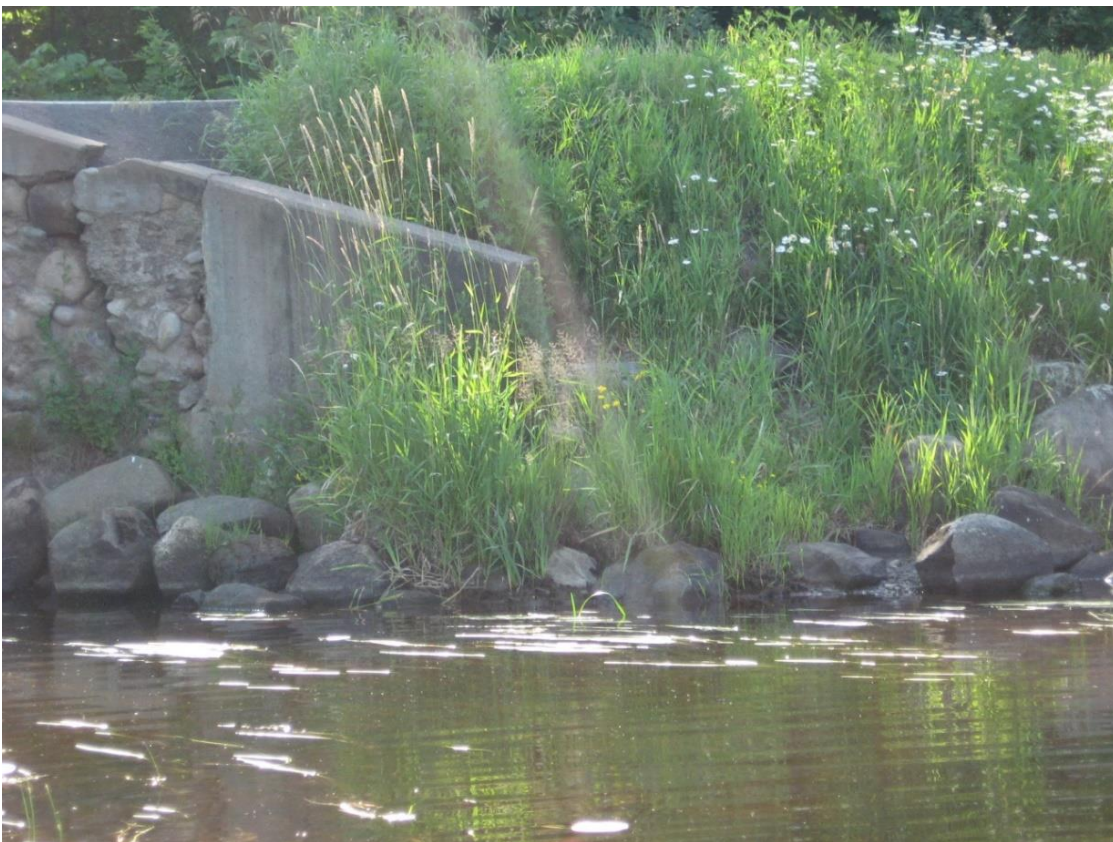
7/3/2020 Minnesuing Creek S side bridge abutment 4 years “after” spraying – native plants have regrown

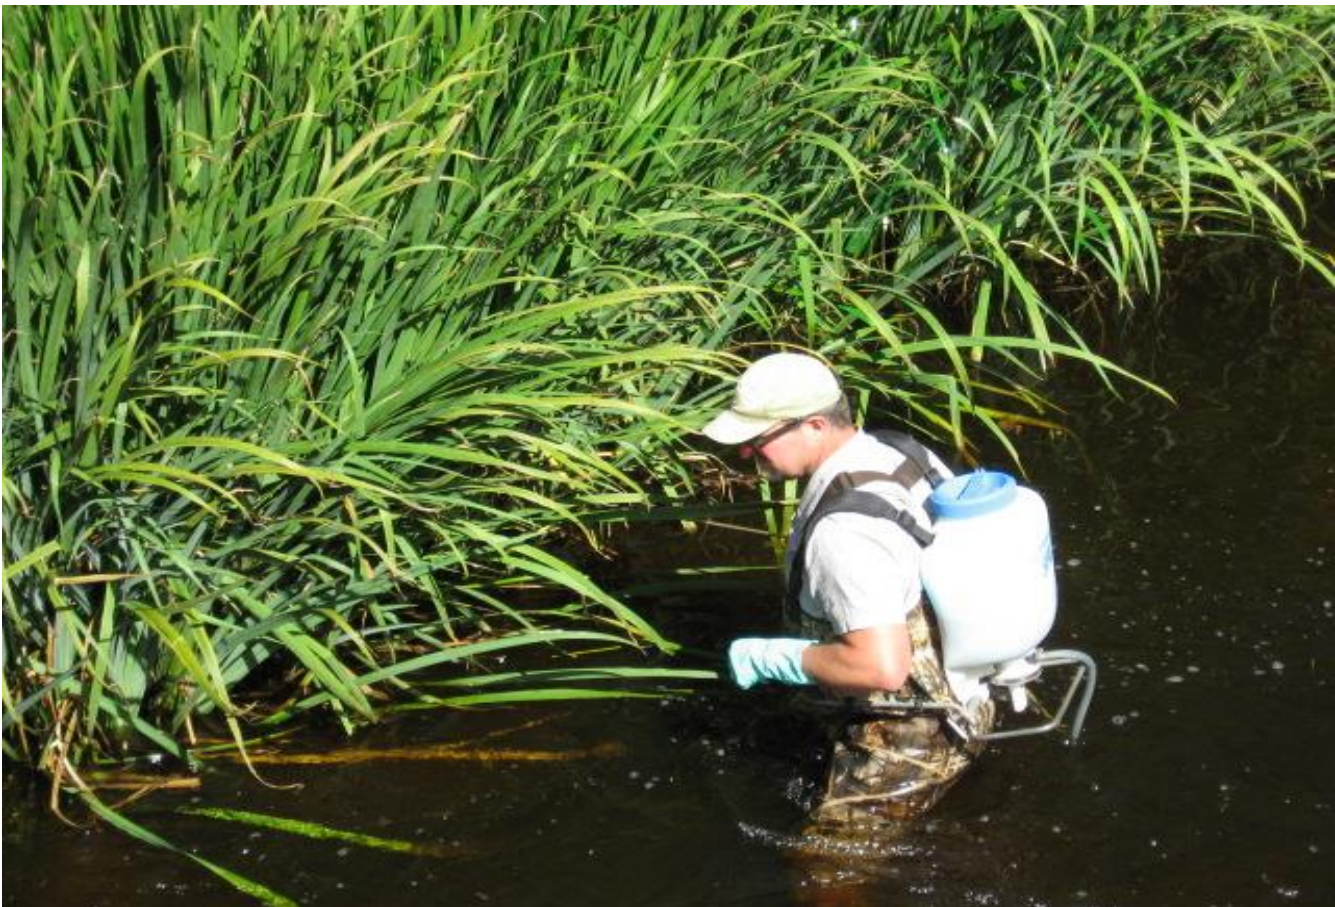
9/12/2016 Minnesuing Creek north side being sprayed

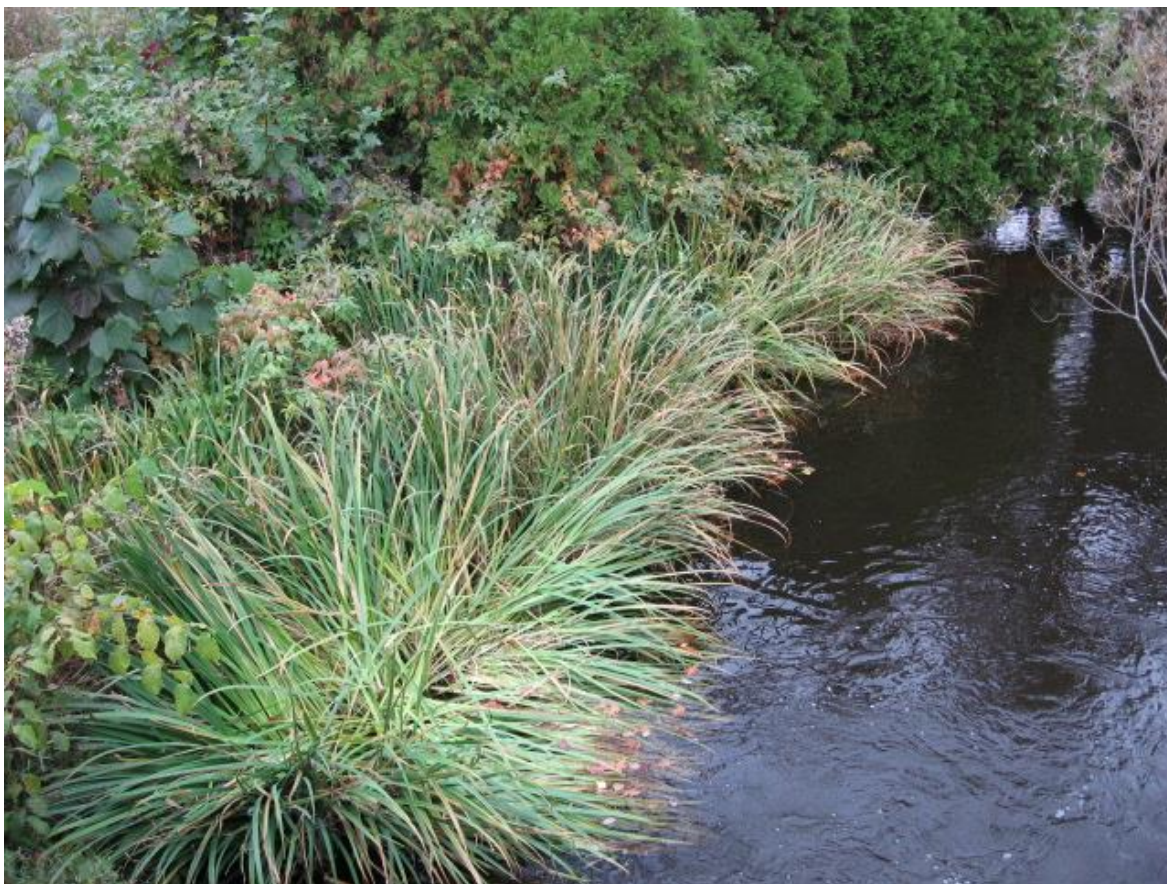
10/12/2016 Minnesuing Creek north side "after" – 34 days after spraying

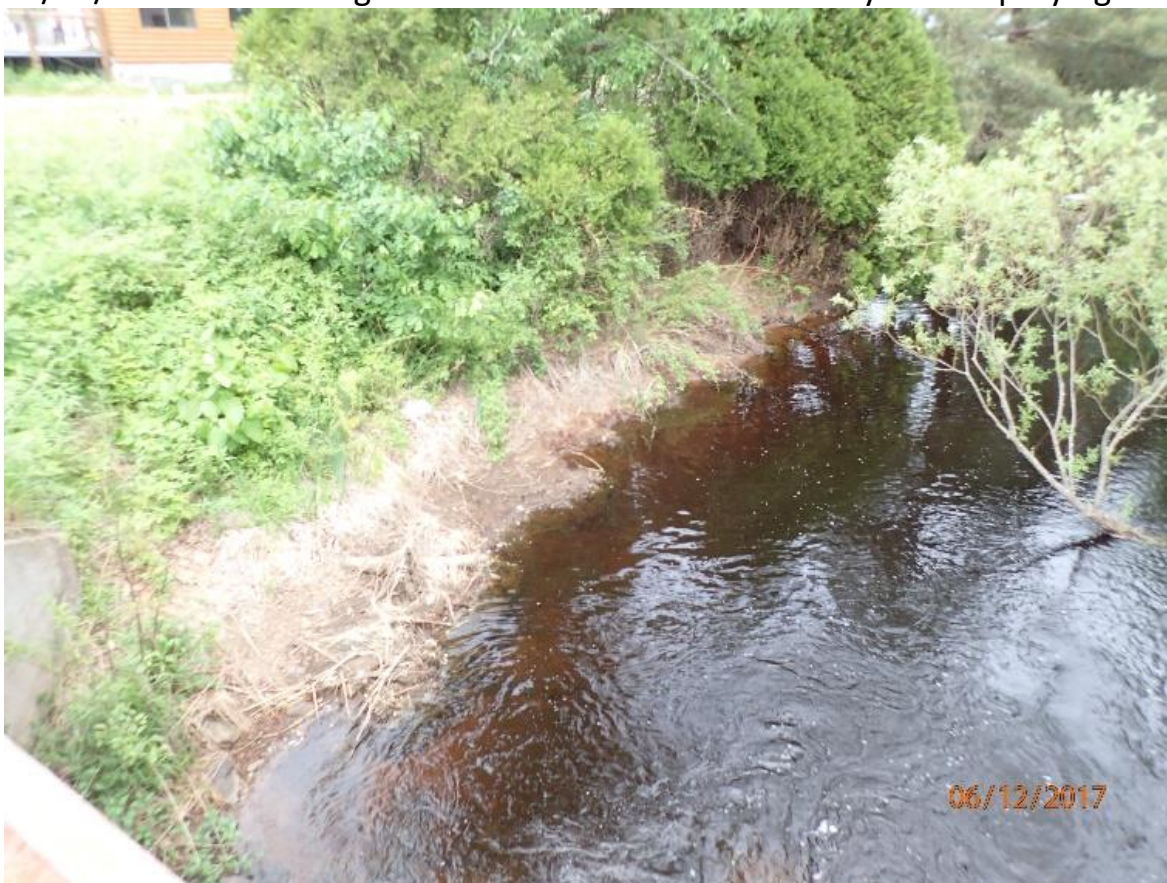
6/12/2017 Minnesuing Creek north side "after" – the year after spraying

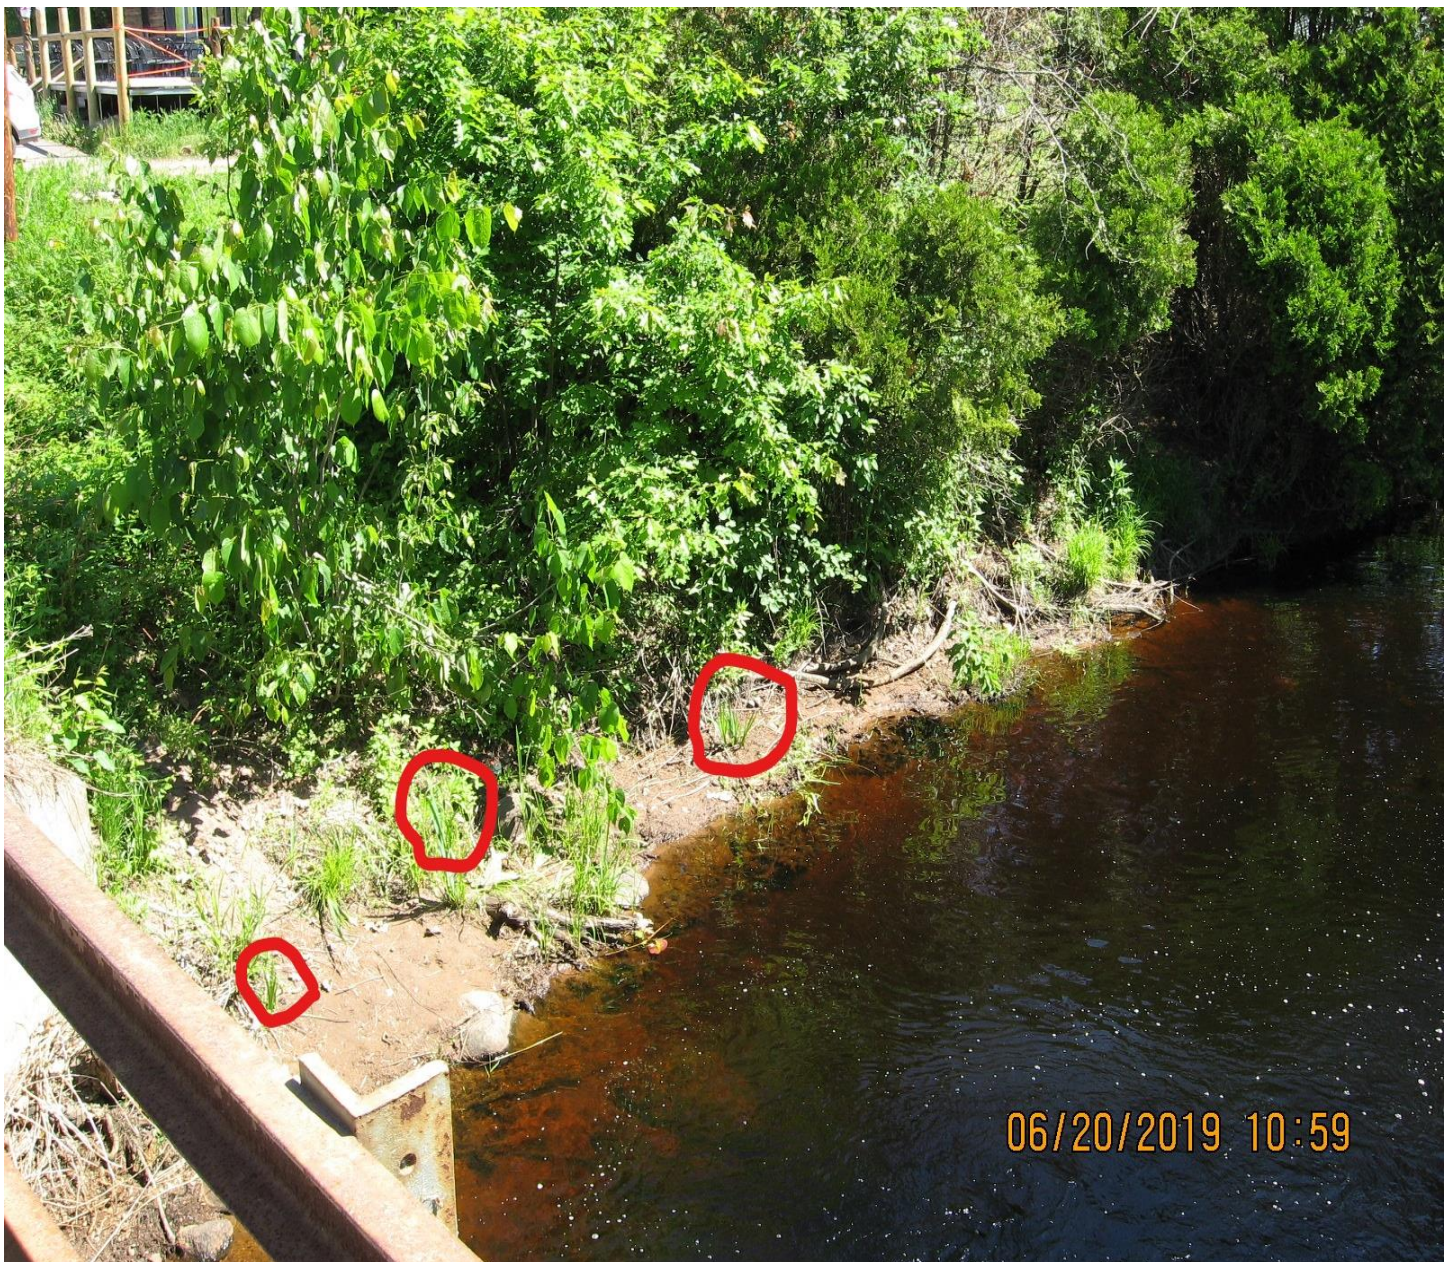
6/20/2019 Minnesuing Creek north side “after” – 3 years after spraying. Only 3 small YFI plants remain. Easy targets for cut stump or butcher knife digging treatment.

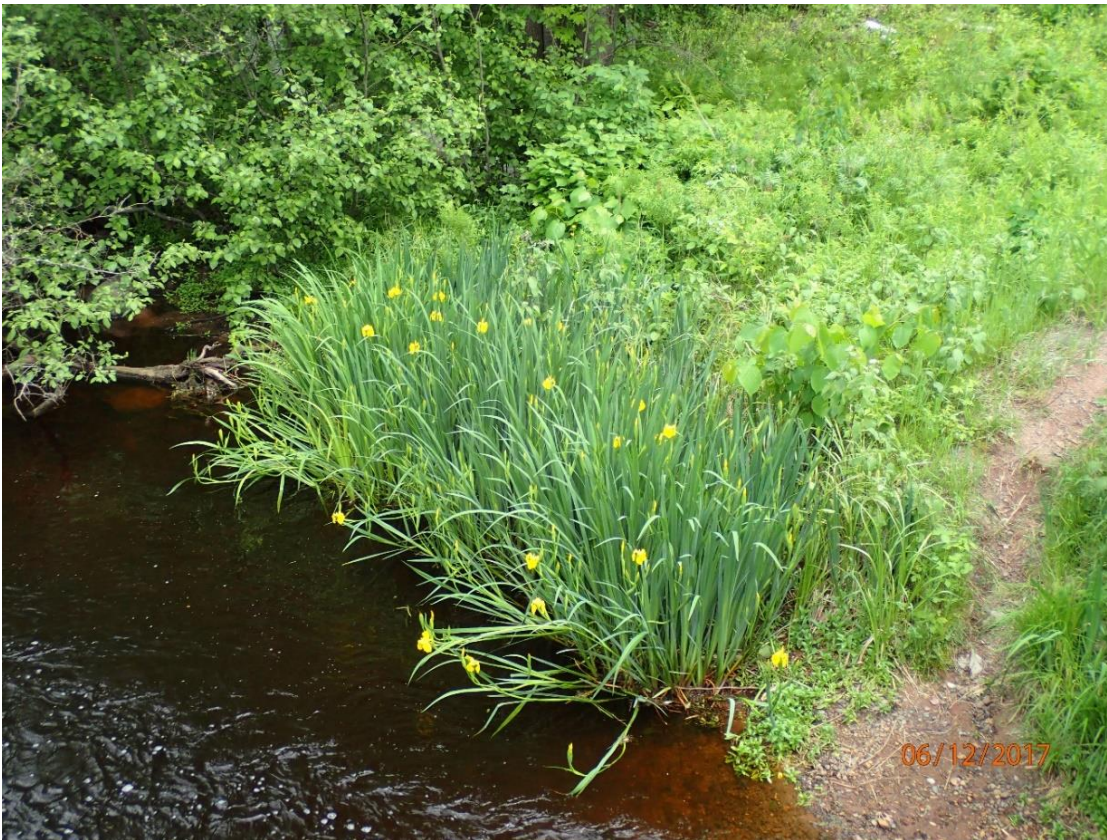
6/12/2017 Comparison - Minnesuing Creek south side not sprayed (Douglas County bans use of herbicides on county property). This is directly across the creek from the north side photos. The creek is about 15' wide.

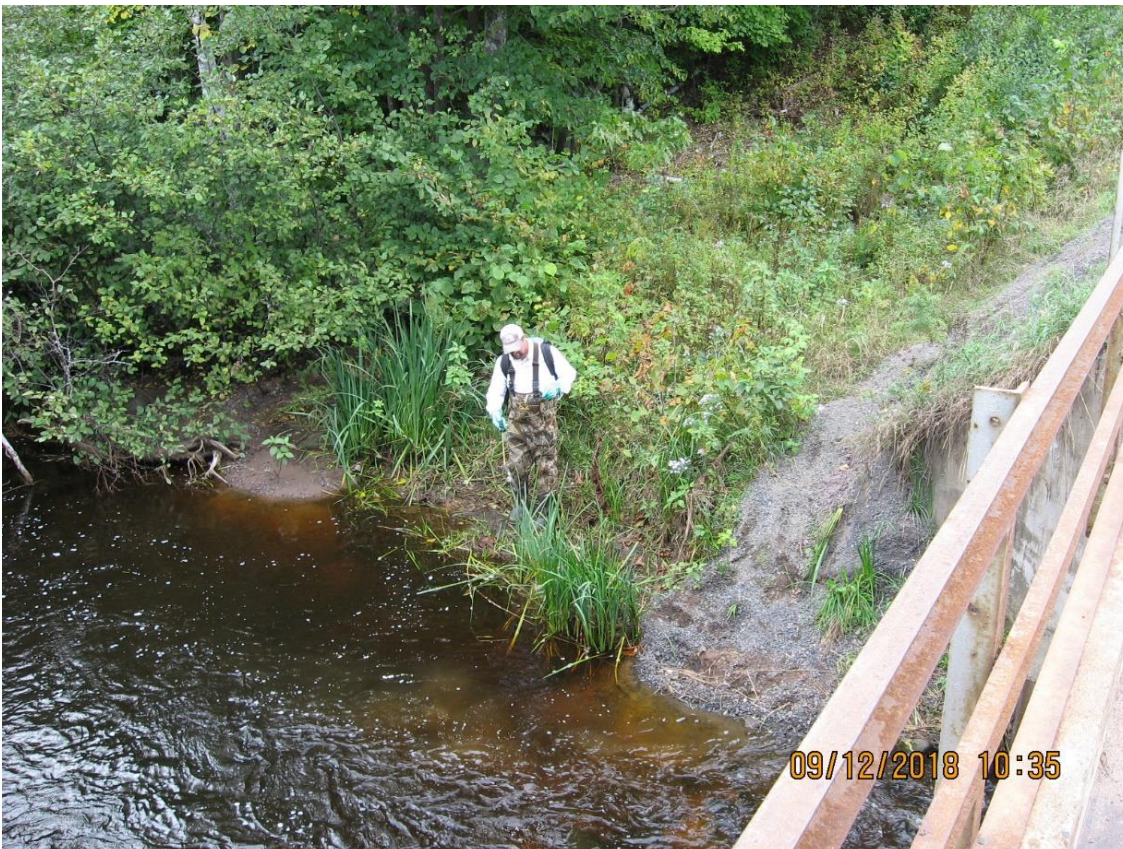
9/12/2018 Minnesuing Creek south side being sprayed after exemption was received

As previously detailed in the 2018 yearly activity, LMSD applied for and received an exemption from Douglas County to allow spraying of the south side of the creek and that was completed 9/12/2018.

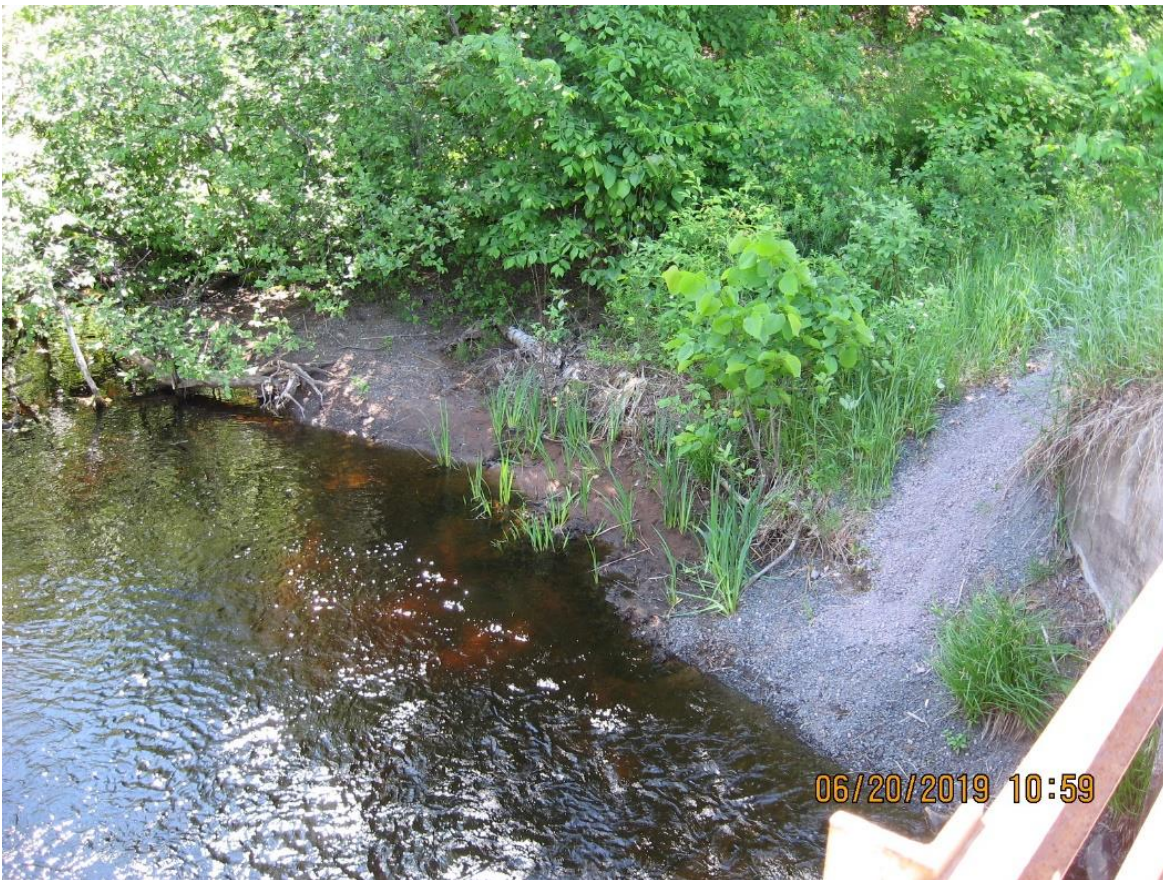
6/20/2019 Minnesuing Creek south side – 9 months “after” spraying. Exemption approved by Douglas County. These re-emerging plants were cut stump treated 9/17/2019.

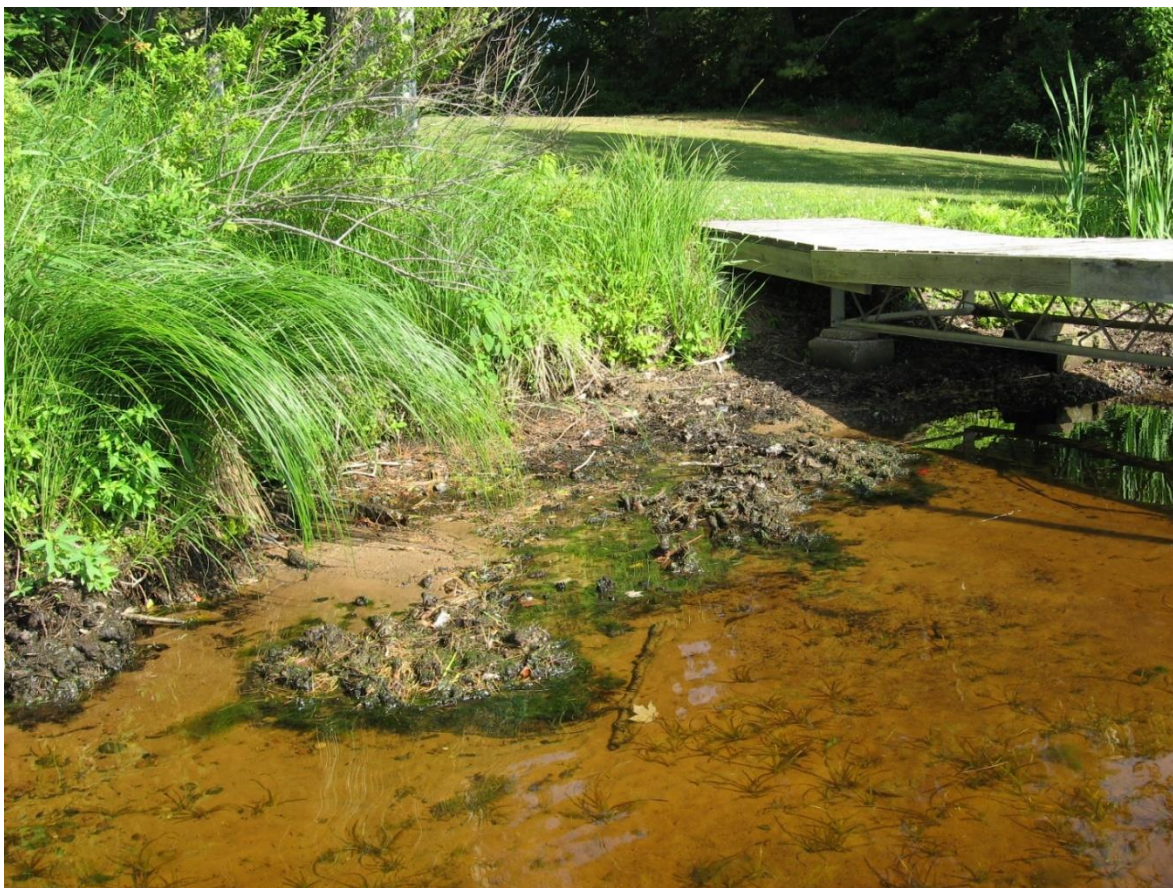
7/2/2020 Property 8900 south side of old dock "after" final spraying 9/12/18, only inert rhizome clumps remain

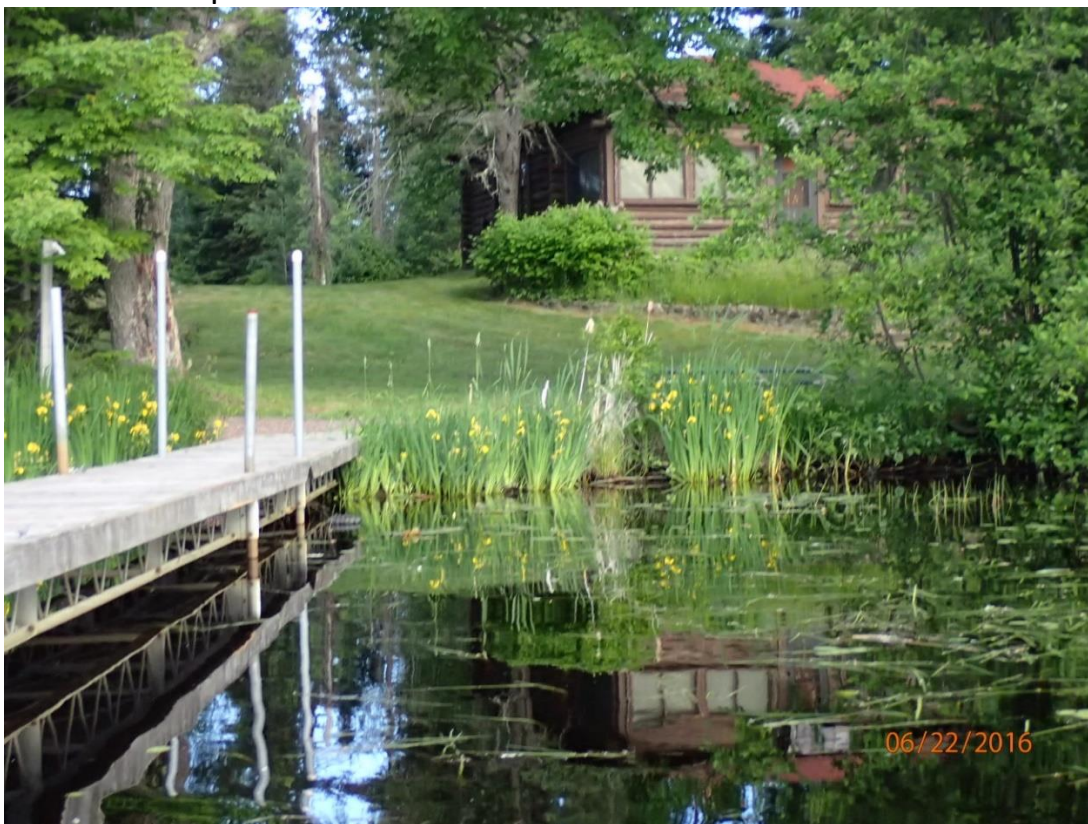
6/22/2016 Property 8900 north side of old dock "before"

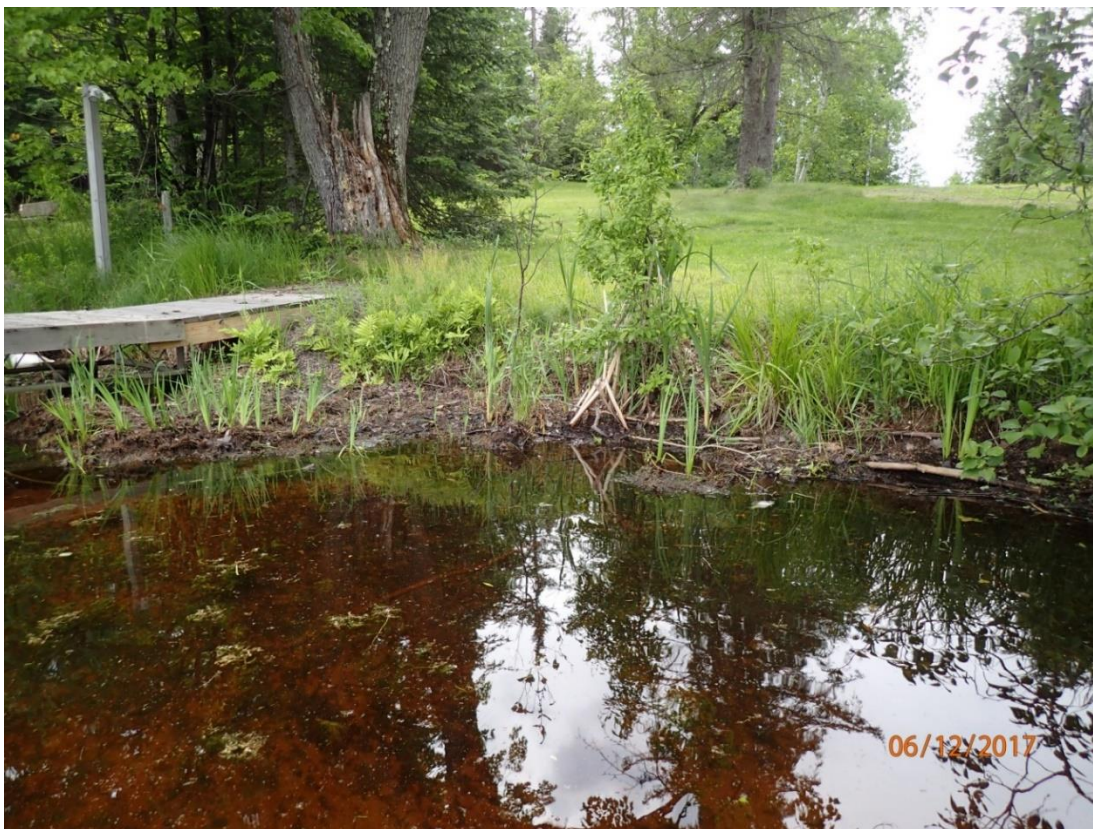
6/12/2017 Property 8900 north side of old dock "after" wipe on glove treatment 9/14/2016

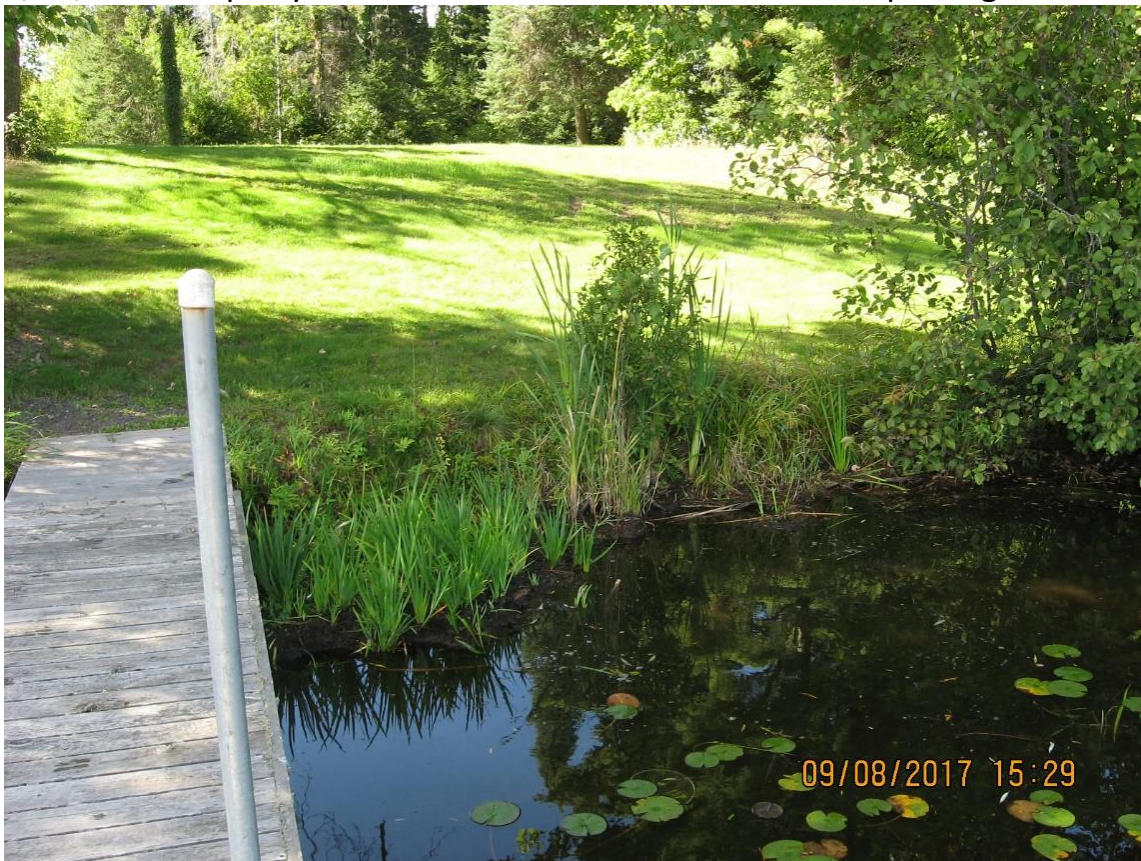
9/8/2017 Property 8900 north side of old dock prior to spray retreatment this date. YFI was growing back after the wipe on glove treatment. Spray retreat this date.

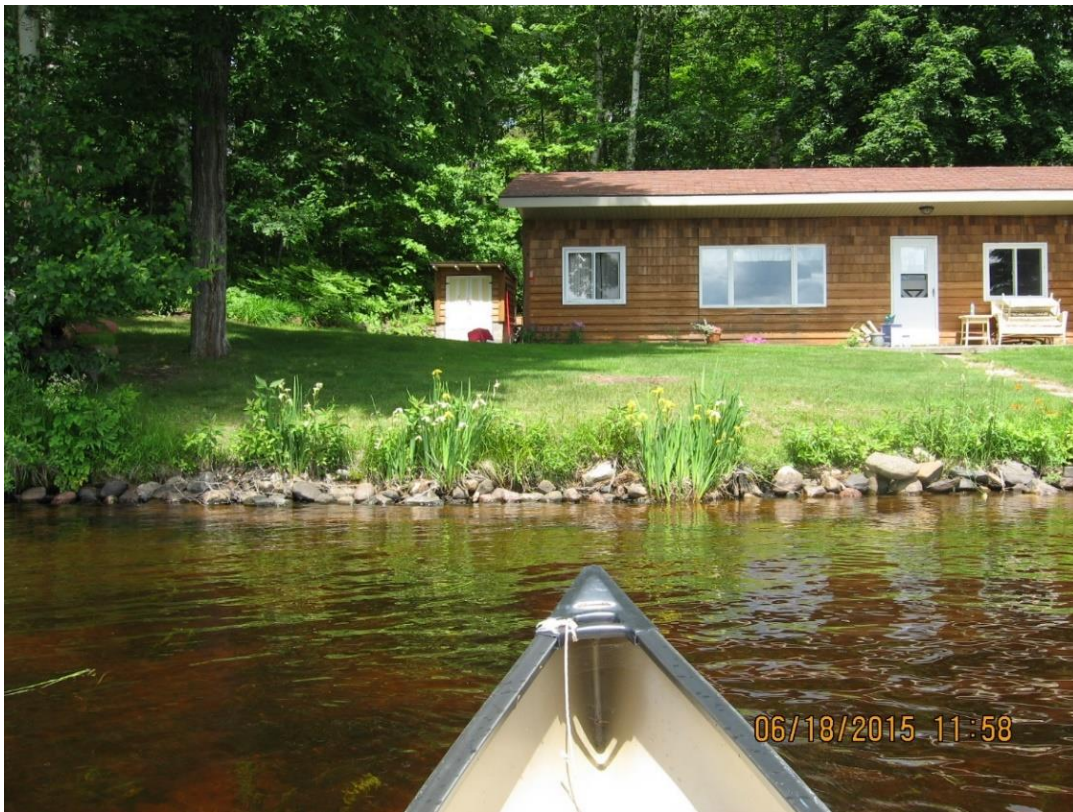
6/18/2015 Property 9200 "before"

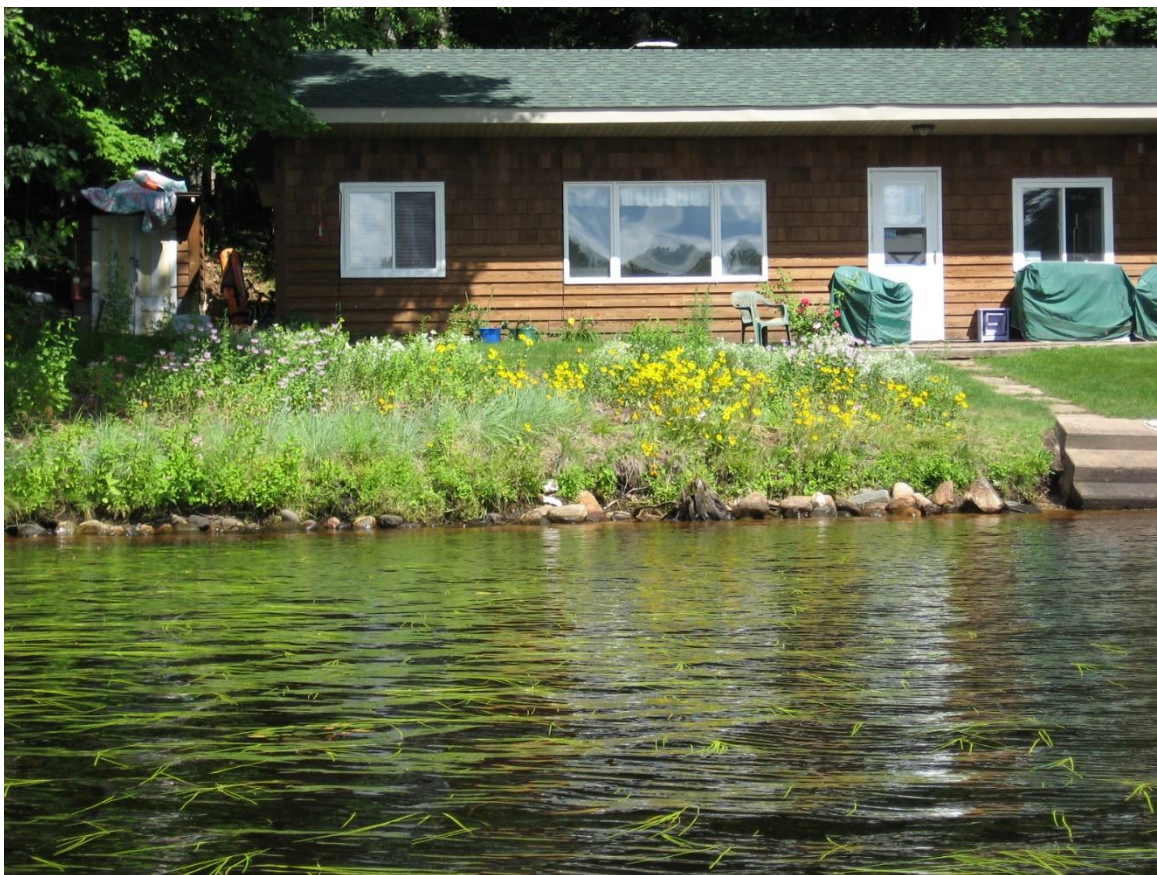
7/30/2020 Property 9200 “after” homeowner spraying and 2017 Healthy Lakes restoration

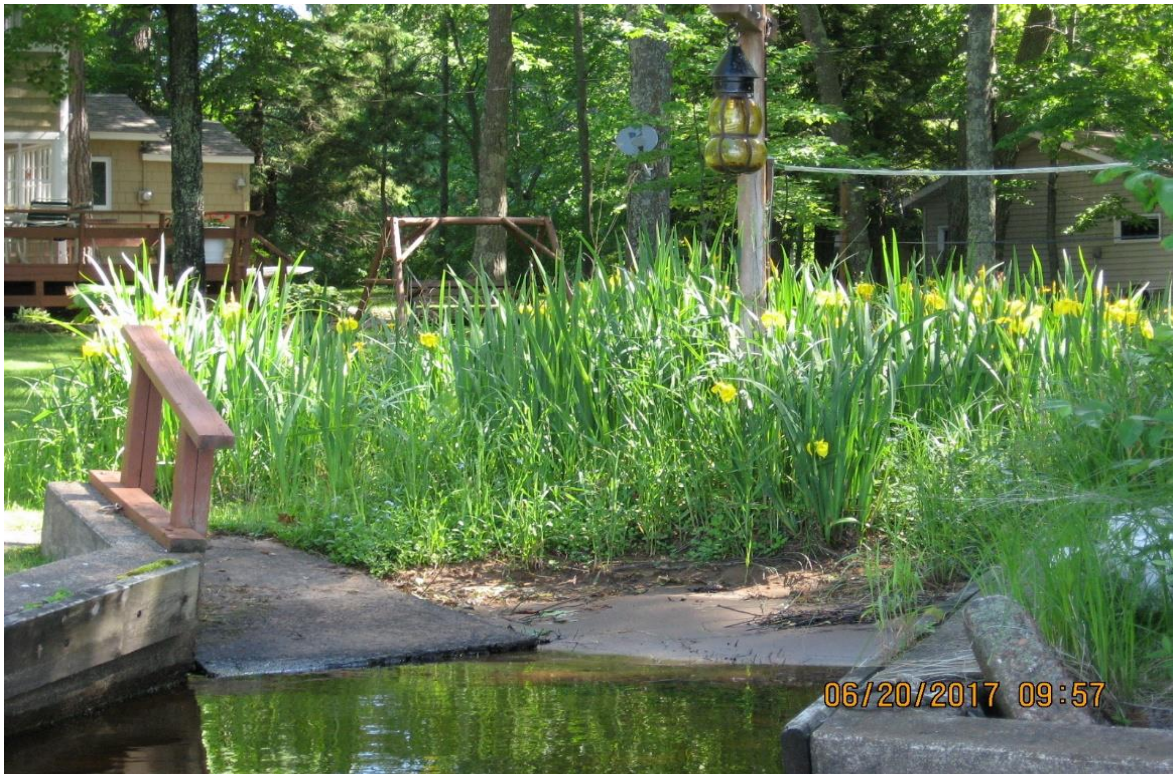
6/20/2017 Property 4400 "before"

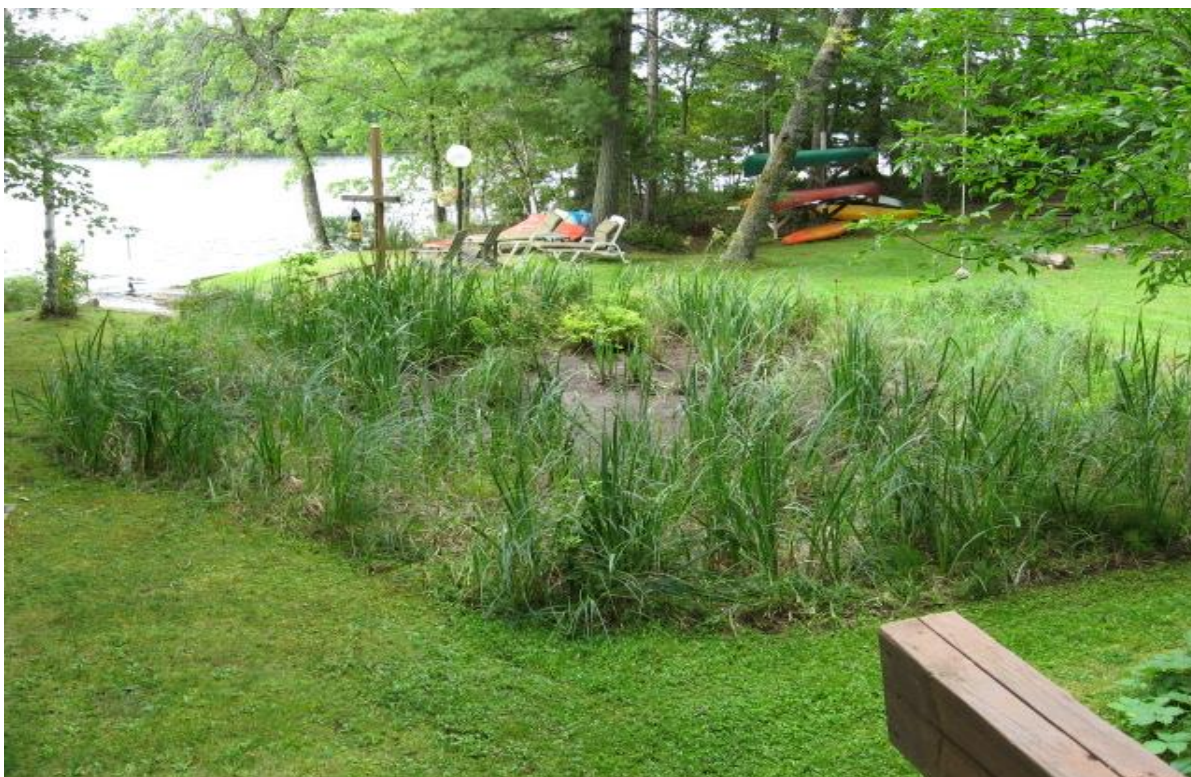
8/25/2017 property 4400 "before" – nearly 1000 square feet of mature YFI

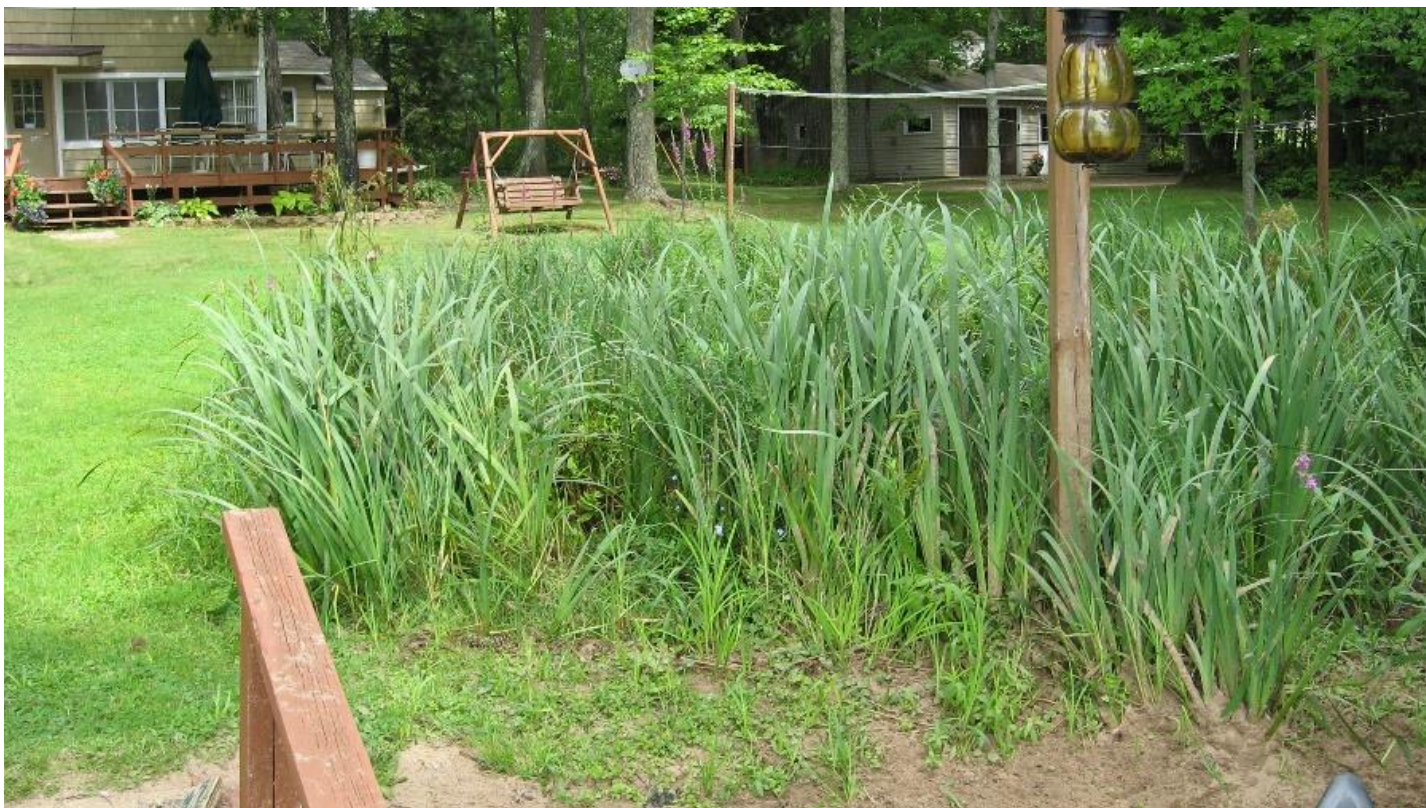
8/25/2017 Property 4400 “before”

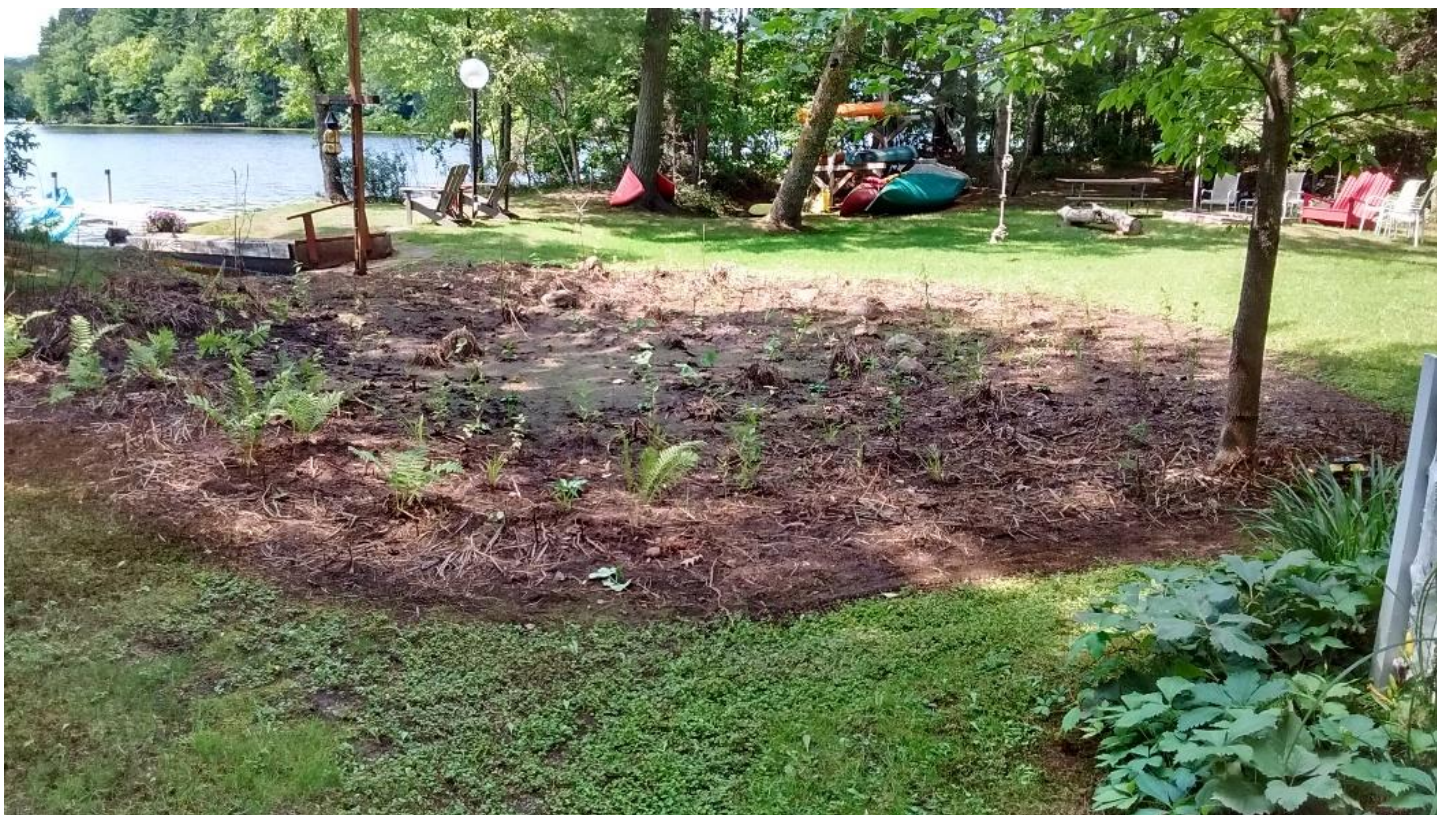
8/6/2018 Property 4400 “after” 9/18/2017 spraying and then digging of several isolated YFI plants early in 2018. This site was restored in 2018 using a “double” Healthy Lakes Grant.

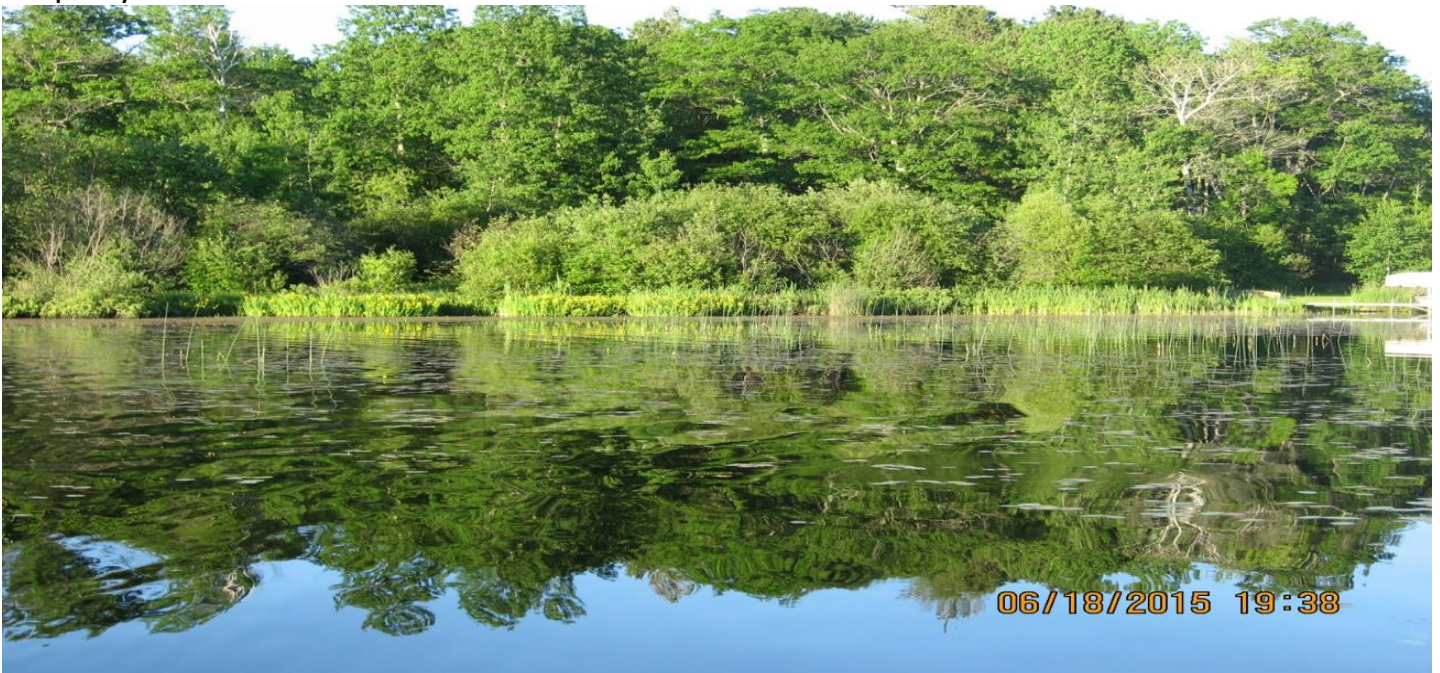
6/18/2015 Property 2100 “before” – this is a 40’-50’ stretch of mature YFI about 3’ deep. This was one of the largest sites on the lake as the project began.

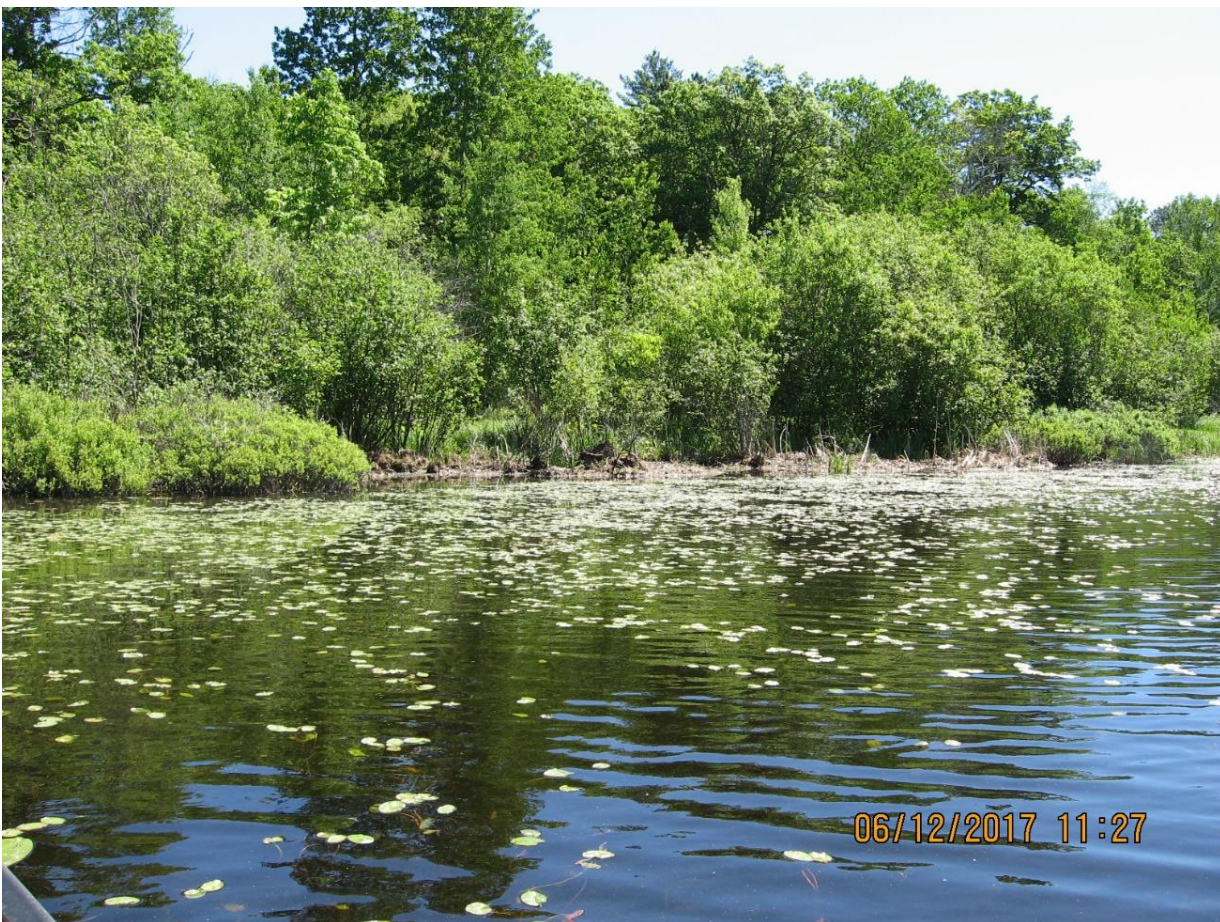
6/12/2017 Property 2100 “after” spraying 9/8/2016. Spraying was about 65% effective.
