FINAL REPORT

# YELLOW FLAG IRIS MITIGATION – LAKE MINNESUING

**JUNE 3, 2015 – DECEMBER 31, 2020**

**SPONSOR – LAKE MINNESUING SANITARY DISTRICT**

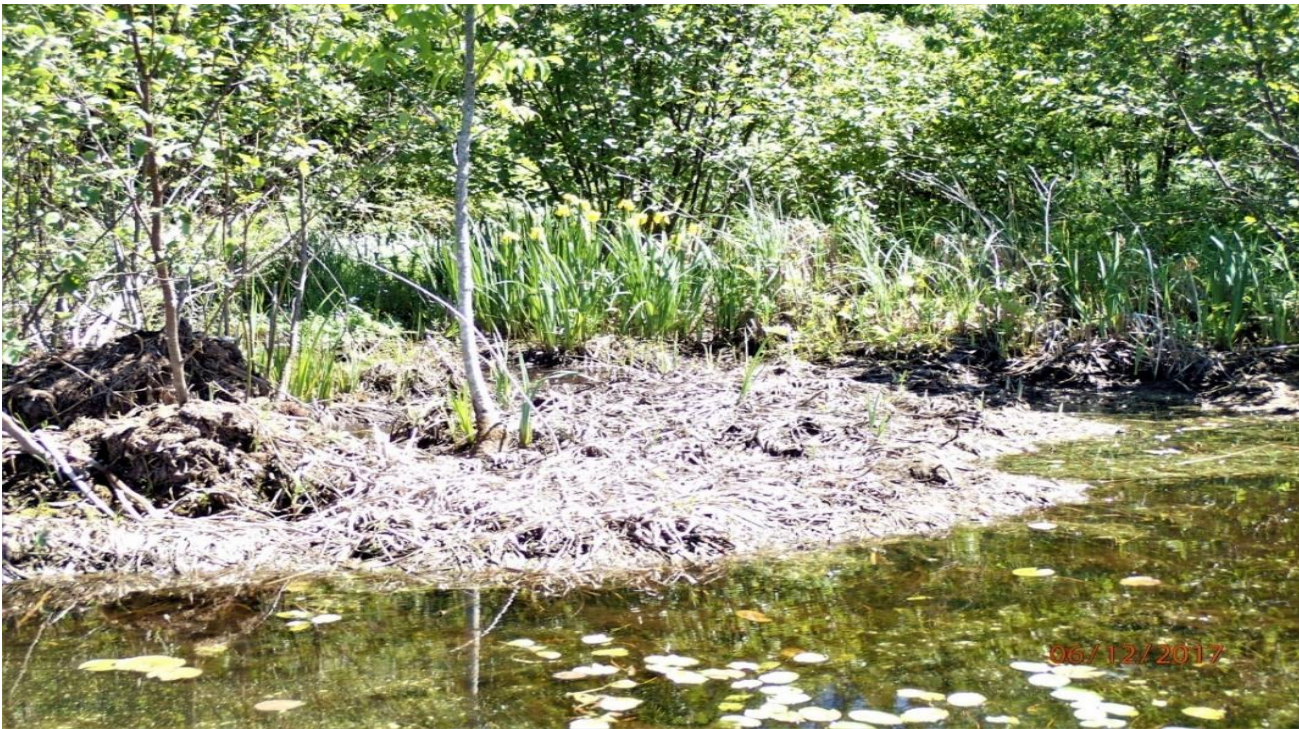
6/12/2017 Property 2100 “after” spraying 9/8/2016 – closeup. YFI nearest the lake was eliminated but remains further shoreward.

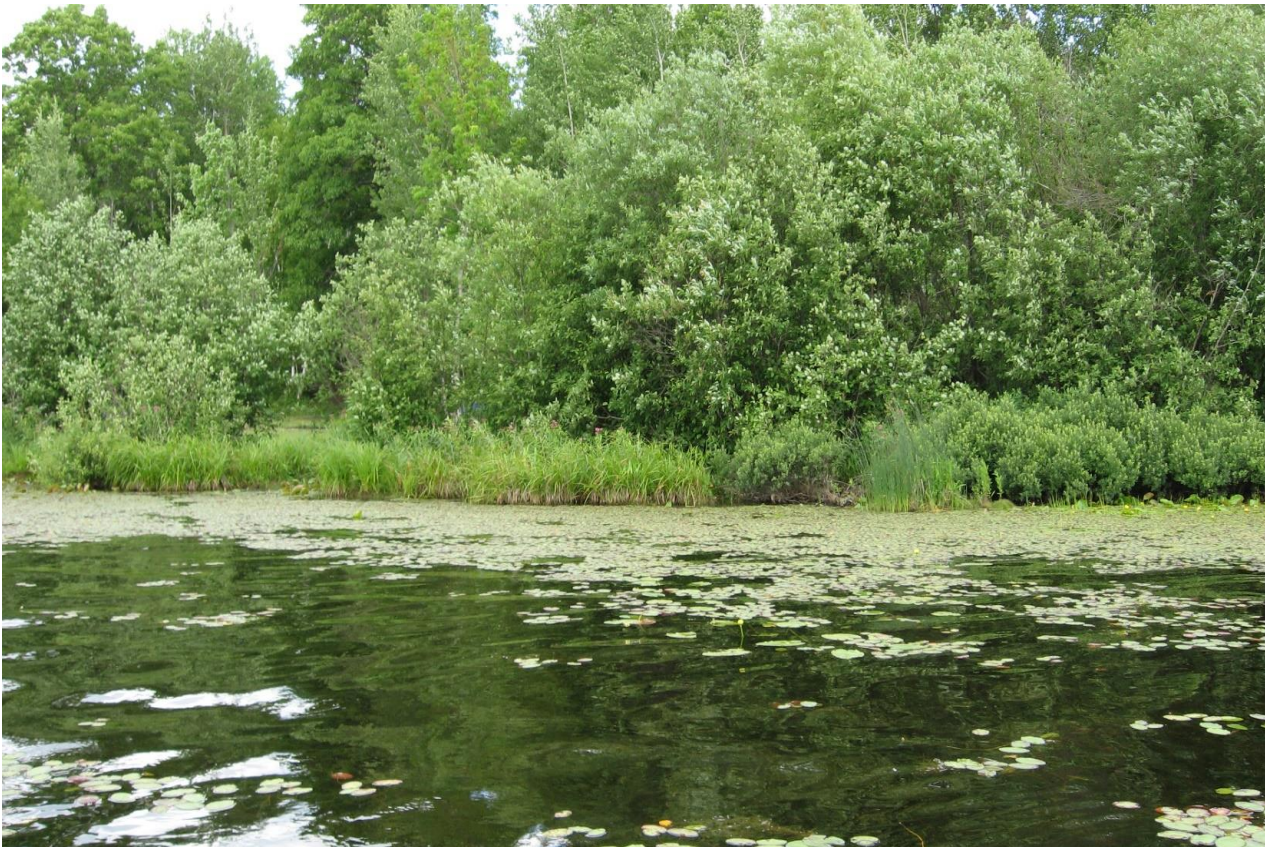
6/30/2019 Property 2100 “after” spraying 9/8/2016 and retreatment spray 9/8/2017. Most all YFI is gone and Joe Pye Weed has returned and sweet gale is thriving. 2 spray treatments have resulted in 80% effectiveness on an area that was extremely heavily infested.

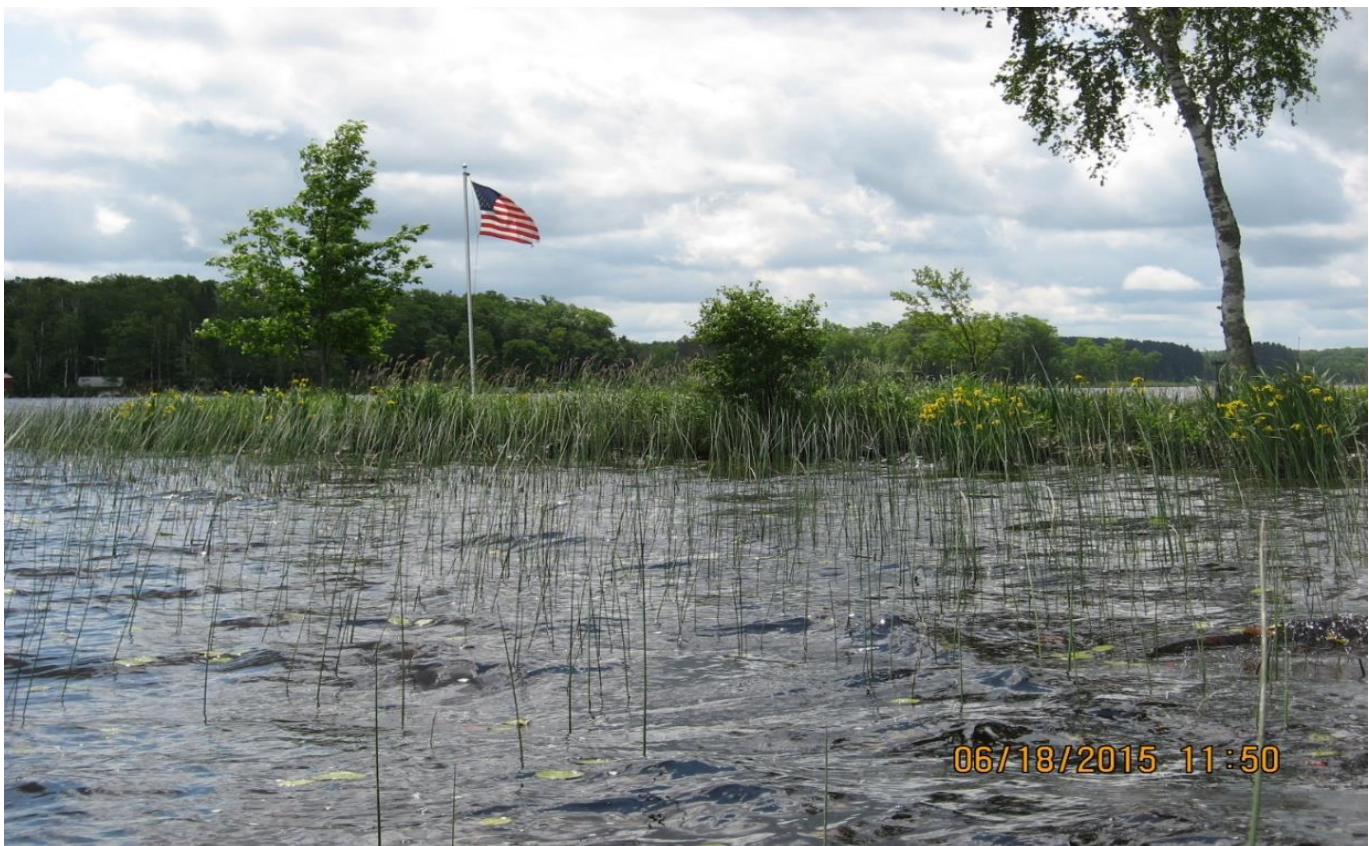
During the 2015 annual assessment, the shoreline of this property was found to be almost completely infested with YFI. On our herbicide permit application for 2016, the NE facing shore was estimated to have a stand of YFI 55' long and about 3' deep and the SE shore 45' long and 3' deep.

6/18/2015 Property 9300 NE shore "before"

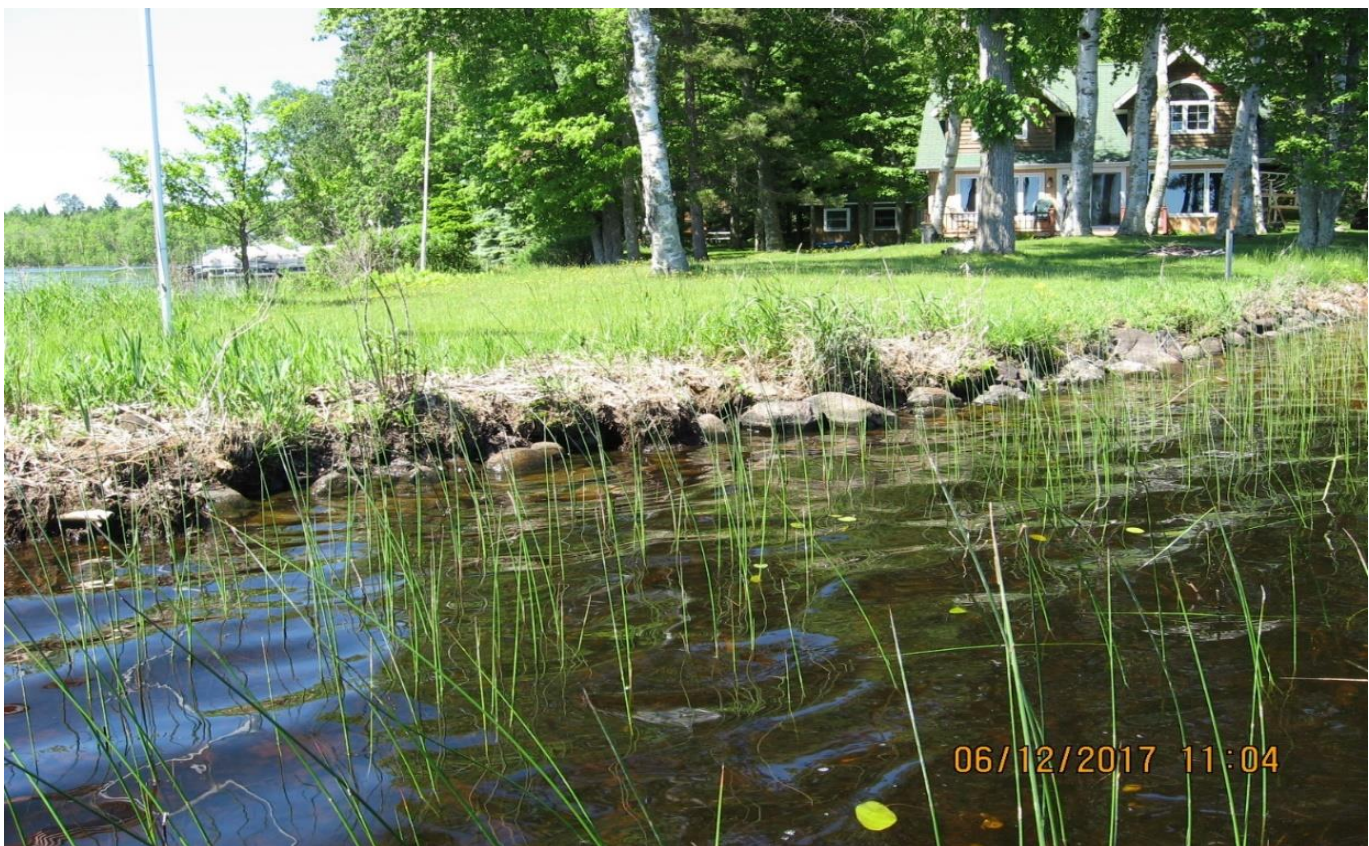
6/12/2017 Property 9300 NE shore "after" initial spraying 9/8/2016. Massive rhizome clods (i.e. 3' long and 18" to 20" in diameter) were left on the shore showing nothing green.

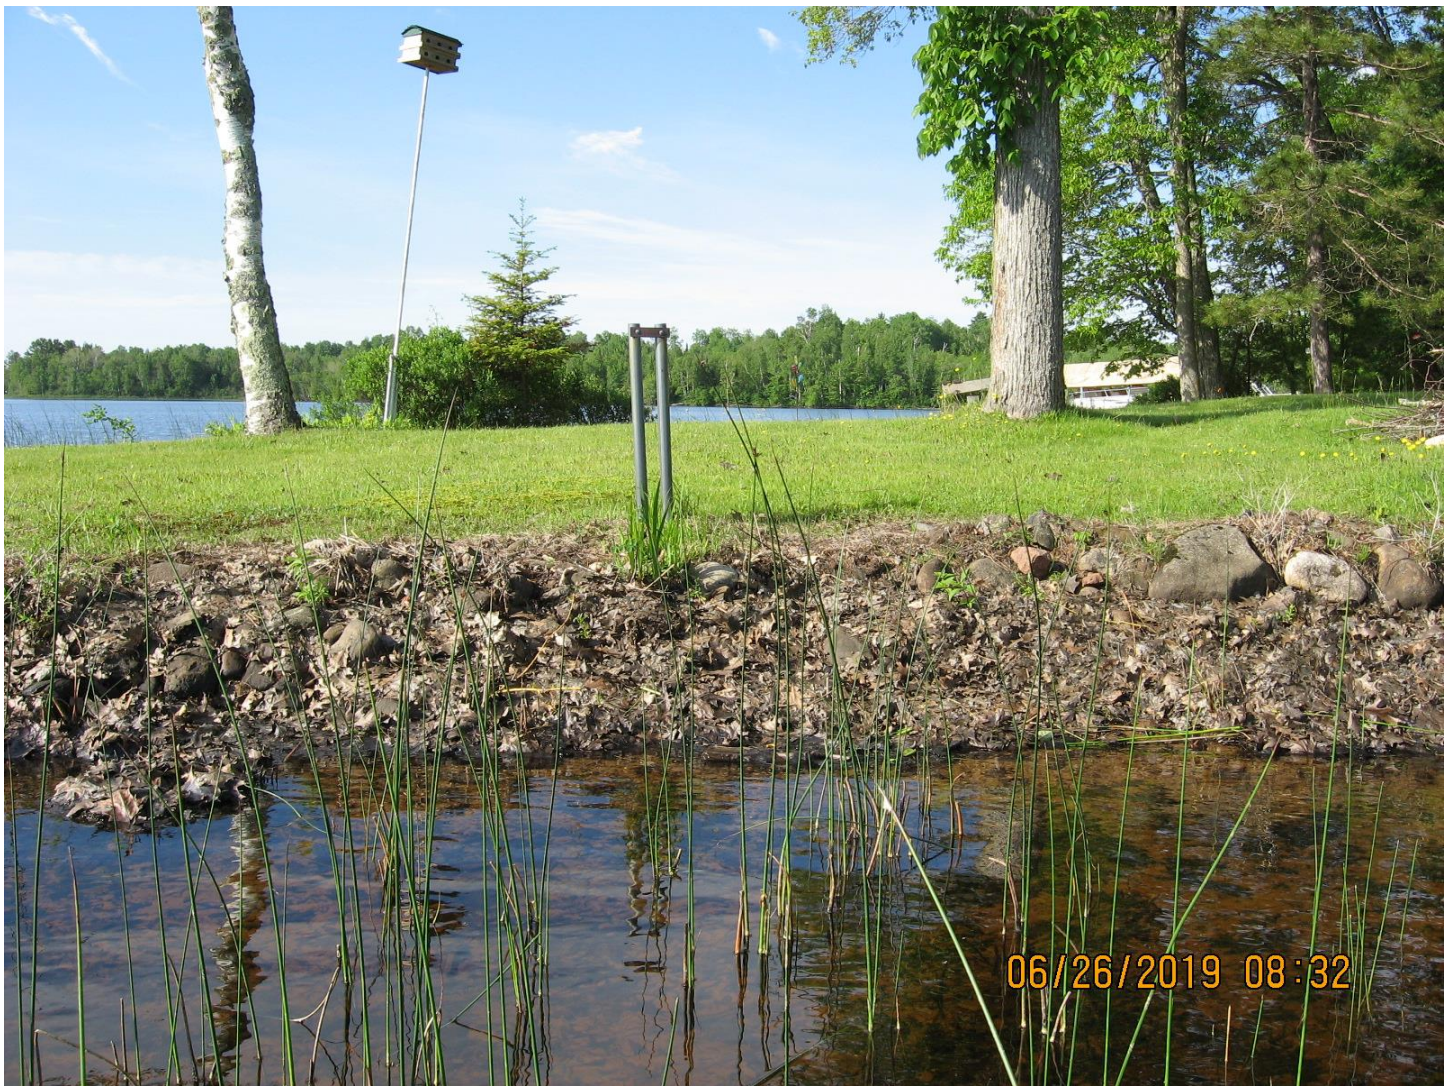
6/26/2019 Property 9300 NE shore “after” initial spraying 9/8/2016, property owner cut stump treatment in 2017 and spray retreatment in 2018. A follow up spray retreatment was completed 9/10/2020.

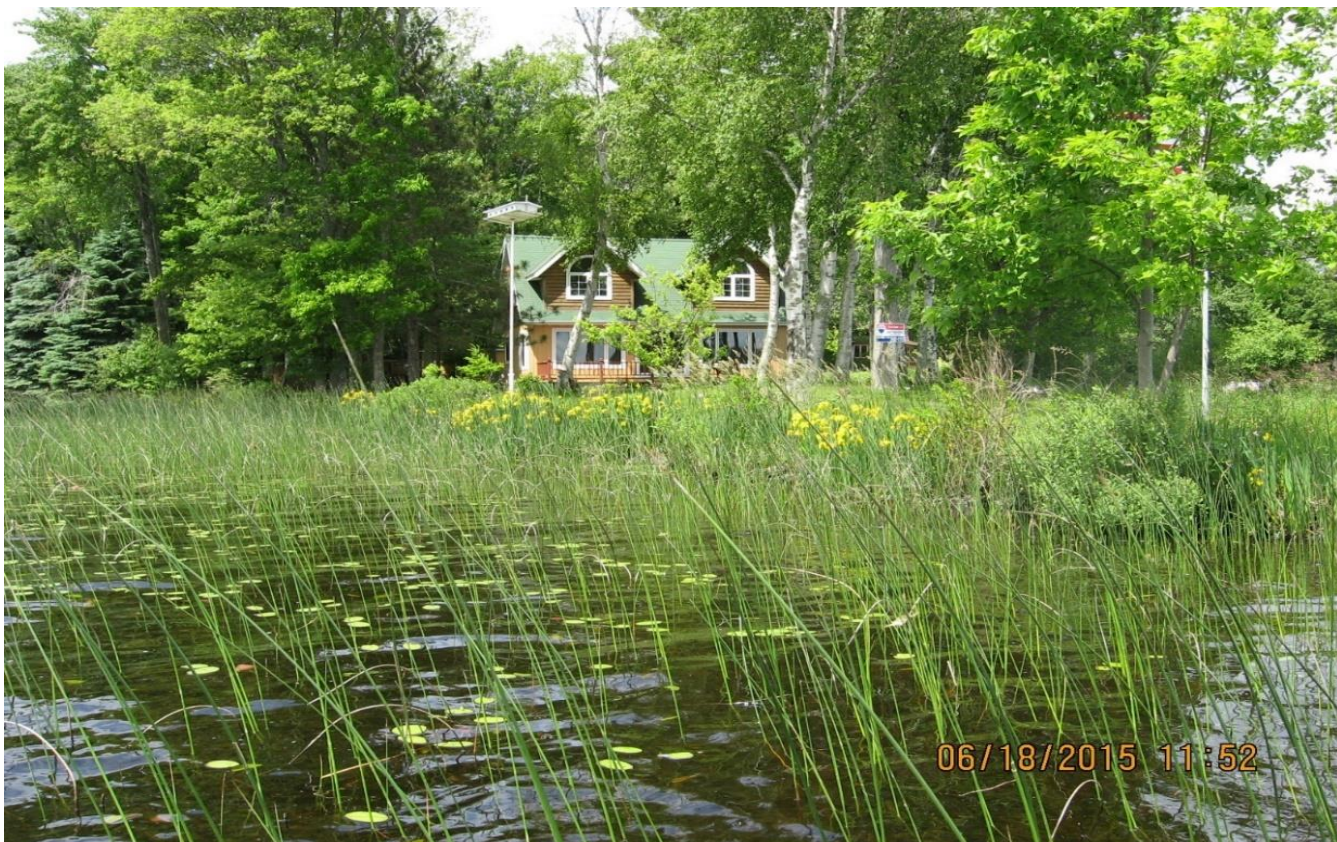
6/18/2015 Property 9300 SE shore “before”

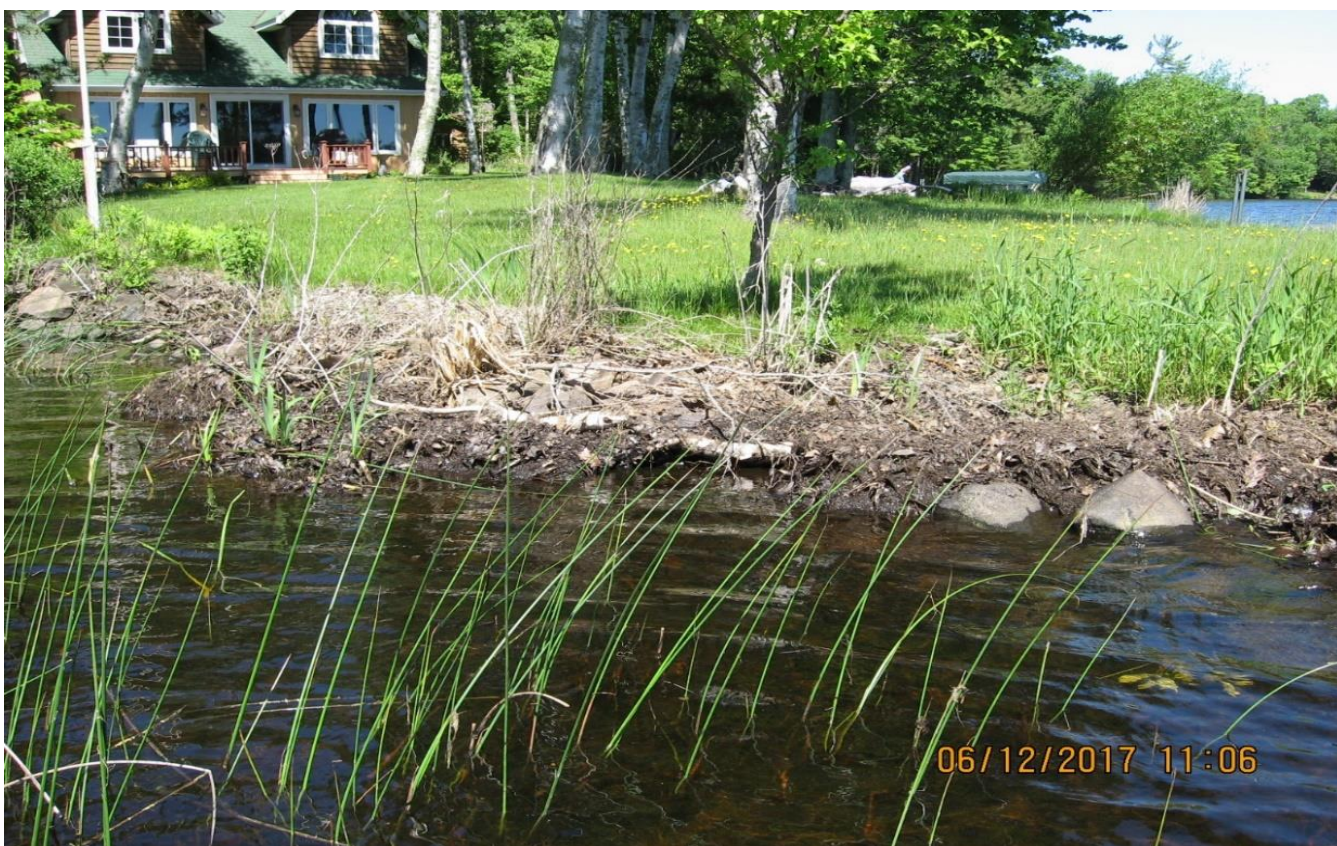
6/12/2017 Property 9300 SE shore “after” initial spraying 9/8/2016. The 2016 spraying was about 70% effective at eliminating YFI

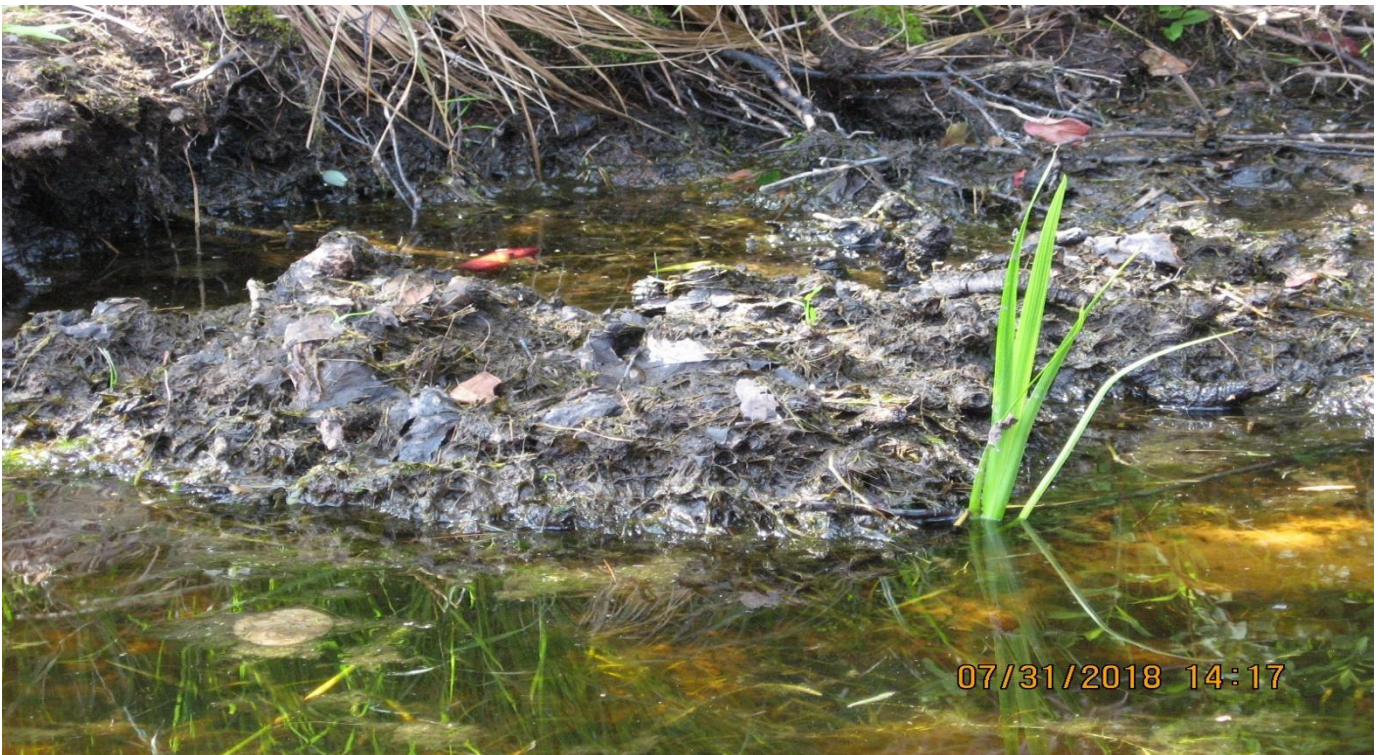
7/31/2018 Rhizome mass after spraying. This mass is approximately 4' long. Some YFI life remains.

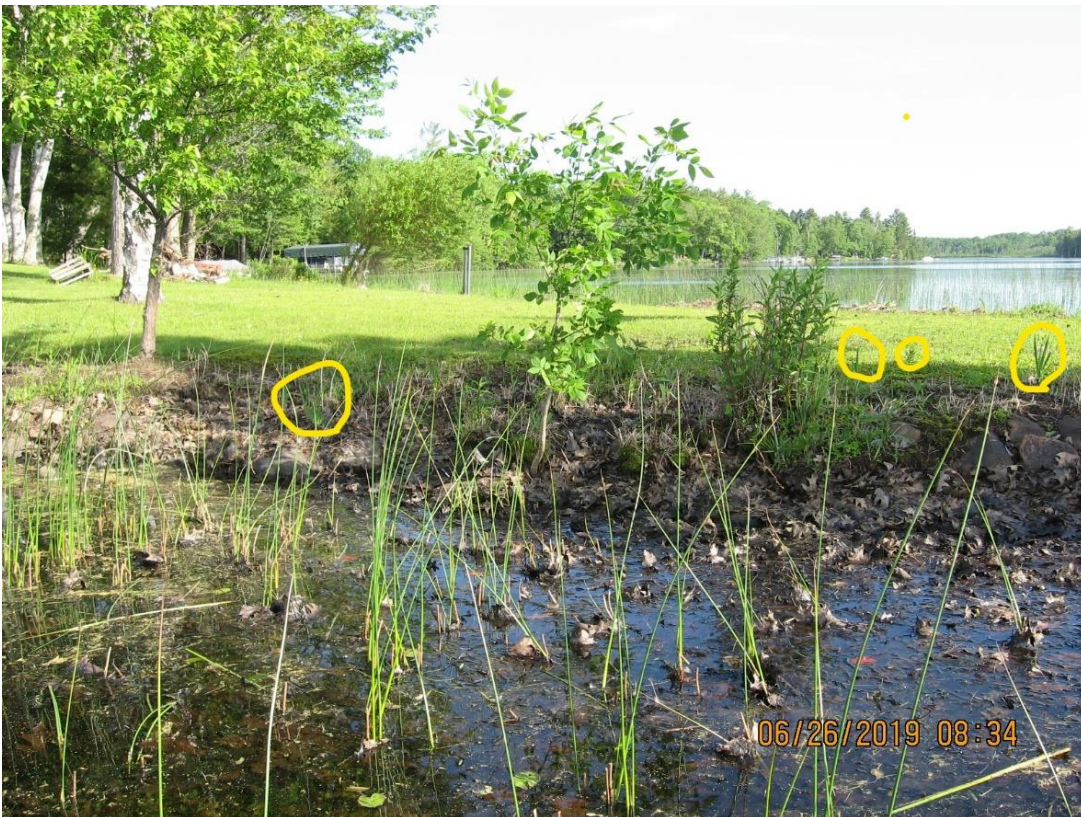
6/26/2019 Property 9300 SE shore "after" initial spraying 9/8/2016, property owner cut stump treatment in 2017 and spray retreatment in 2018. Some small YFI plants remain. A follow up spray retreatment was completed 9/10/2020.

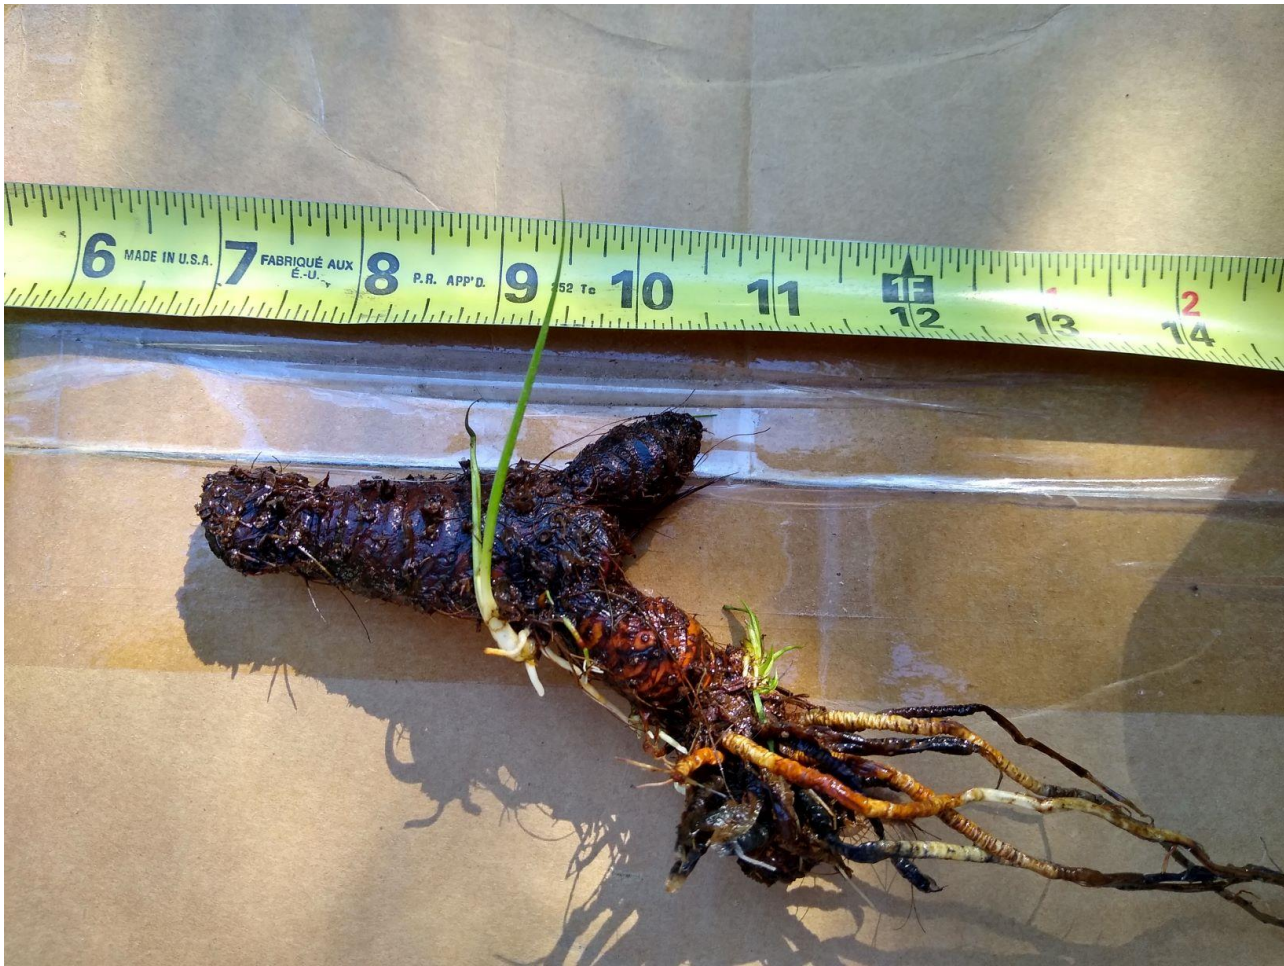
9/4/2020 YFI rhizome shown. Even after spraying multiple times over several years, some YFI can persist.
